**Darling Square South East Plot  
Haymarket NSW 2000**

**October 2020**

**JLL Building Management  
Report**

**Date of Report: 15<sup>th</sup> November 2020**

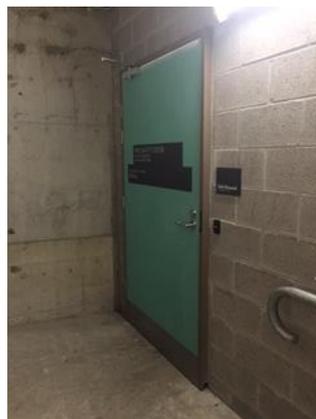
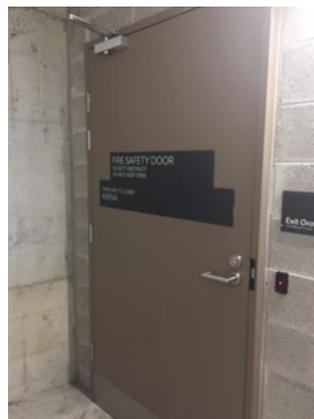
The SEP Annual Fire Safety Statement (AFSS) was completed and submitted to council prior to the due date of 15/05/20. Council had no issues with the submitted statement. There are still issues with some defective doors. Lendlease are working through rectifications of defective doors and fire seals with completion date set in November.

**Update:** Works completed

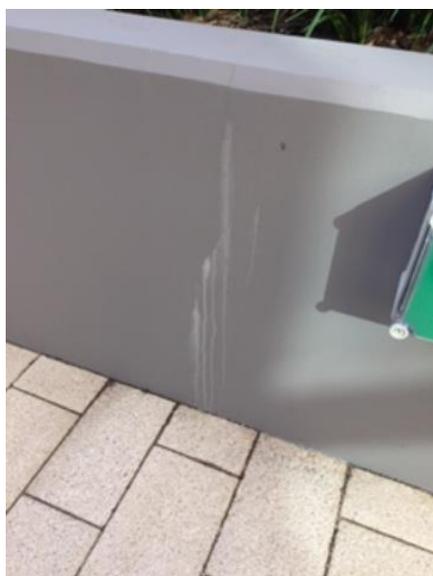
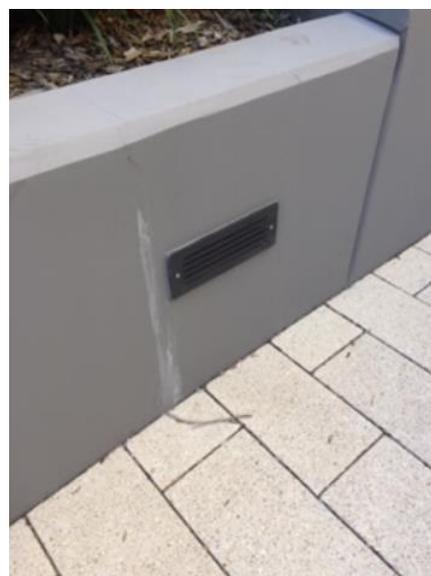
## **3.2 Total of 137 cracks identified in garden concrete walls on level 6 podium**

Cracks in the garden walls were reported to Lend Lease who agreed the issue is defective. During build, the builders didn't insert enough control joints when the concrete pour occurred. With building movement this has caused the concrete to split more than it should. Hair line cracks have occurred close together as a result.

**Update:** Works have now been completed on Podium. Unfortunately it has been noticed by Building Management that efflorescent salts have started to penetrate the newly chasing and painted walls. This has been sent back to Lendlease as a defect.

*Chasing (A chase is a groove or channel cut into an existing layer or substrate to accommodate services such as pipes or cables. Chasing is the act of cutting a chase and is usually undertaken in solid wall or solid floor construction. 20mm wide and 20mm deep, filling with base filler) is the method used by the builders in order to rectify the issue.*

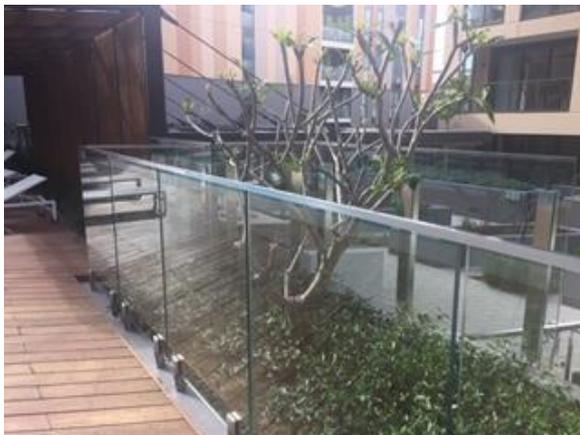
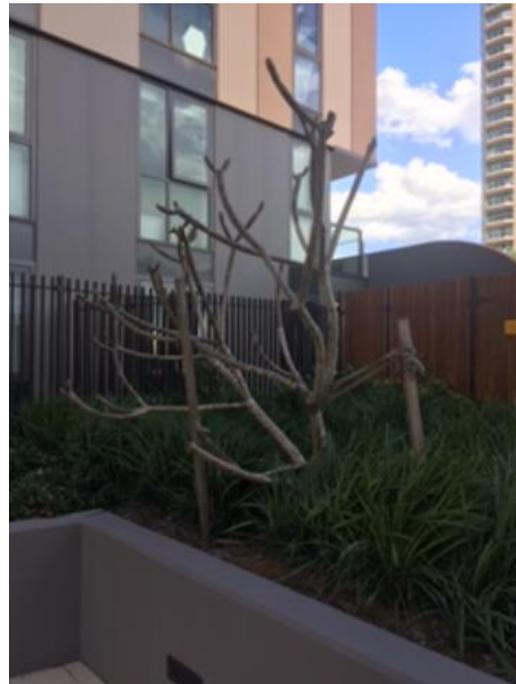
### 3.3 Pool Compliance Issues – Still being assessed by Lend Lease

One item has been flagged by the City of Sydney in their most recent visit; There should be no potential hand holds or foot holds (e.g. shrubs, trees, pot plants, ladders, chairs and other objects) within the 900mm non-climbable zone. The Frangipani tree shown in the below photo did not meet these requirements.

**Update:** Works completed. Lendlease have successfully moved the tree to another location close to the patch of grass on the podium. The pool is now compliant with Australian Standards.

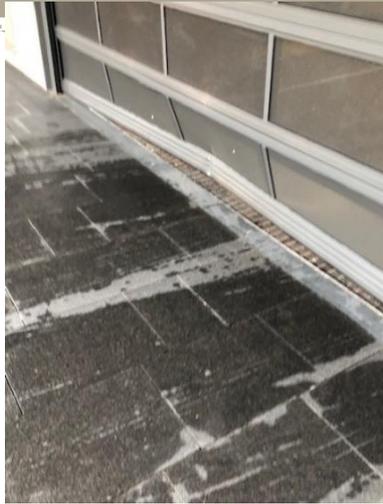
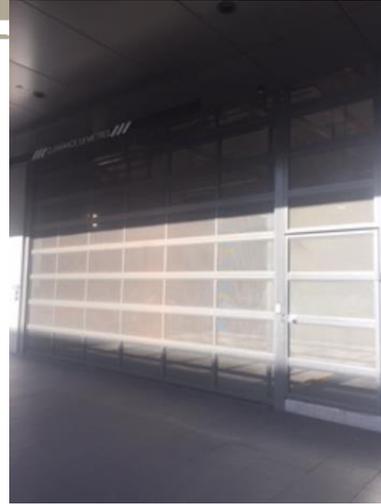
### 3.4 Delivery driver crashing into roller door

On Saturday 5/09/20 a Fantastic Furniture delivery drivers drove into the roller door damaging the door. The driver drove carelessly into the car park ignoring the roller door coming down which has flashing lights to indicate to drivers of the door. A quote has been received to fix the door that is in excess of \$3,200.00. There are still discussions on going with Fantastic Furniture over the responsibility of the invoice. Photos and CCTV footage of the incident have been provided.

**Update:** Works completed. Allgate returned to site on Saturday 14<sup>th</sup> November to replace the incorrect panel which was installed in the first repair works.

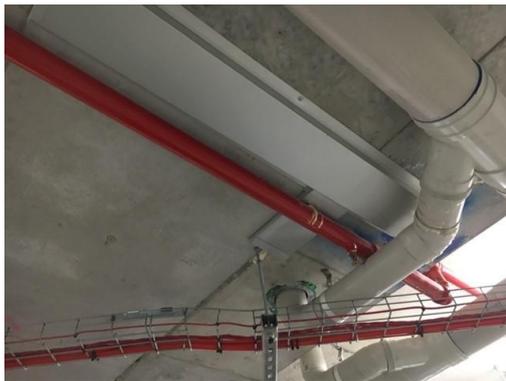
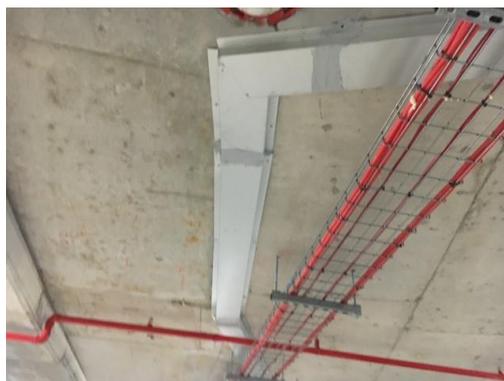
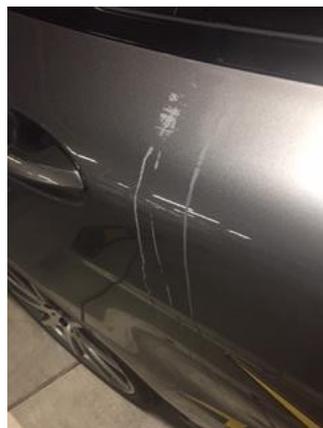
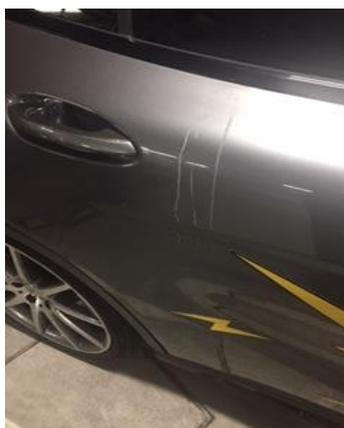
### **3.5 Drip Trays Installed on Level 5 of the Car park**

Drip trays were installed on the ceiling of the level 5 car park and plumbed to storm water as per building practices. This is to assist with any water ingress issues. Undercover or underground car parks are especially prone to water seeping through the concrete. The problem with water seepage dripping onto cars is that the minerals that etch into the surface of the car's paint finish, make it hard to remove with a simple wash.

**Update:** Works completed and car owner reimbursed for the damages.

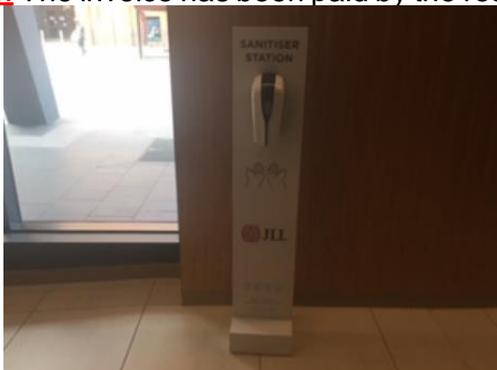
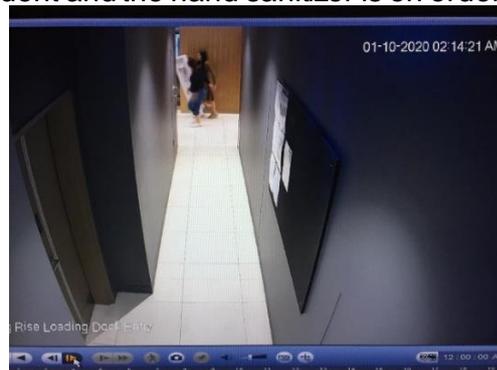
#### 3.8.2 Vandalism of hand sanitizing machine in DR lobby

The hand sanitizing machine in the lobby was vandalised by intoxicated guests of residents on 01/10/20. This was tracked through the CCTV footage and key security system. The persons responsible for the damage have been invoiced and another hand sanitizer ordered at their expense at a cost of \$500.

Update: The invoice has been paid by the resident and the hand sanitizer is on order

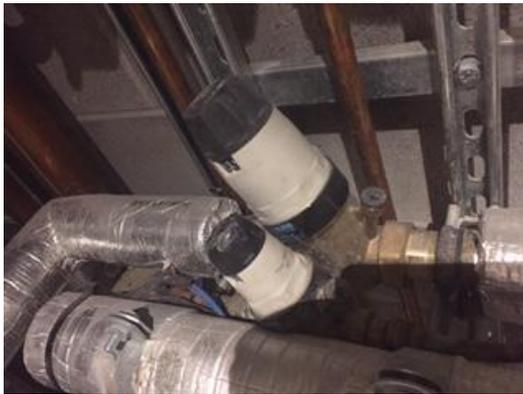
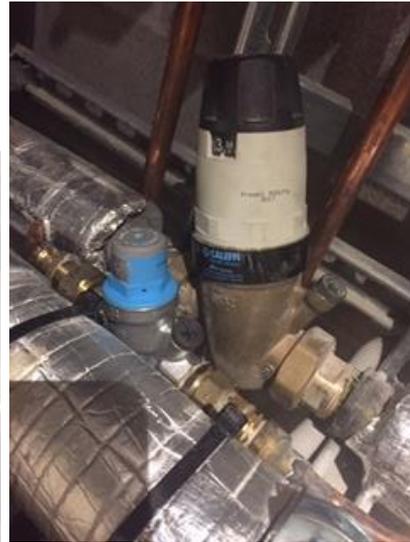
### 3.8.3 Faulty pressure reducing valve replacement

Complaints on floors 2-6 and floor 12 of squealing pipework. Investigated by our plumber Timewise Plumbing and found that the pressure reducing valves in the water services cupboard on the 2<sup>nd</sup>, 3<sup>rd</sup> and 12<sup>th</sup> floors had failed and needed replacing. Building Management to monitor. This seems to be an ongoing issue, Building Management are currently working with Lendlease to clarify if this is a defect.

**Update:** After discussion with Lendlease, the valves are not seen as a defect as they are past their 12 months warranty period. One more valve has failed on level 14 since the last BMR. Building management are monitoring the valves to determine if this needs further investigation.

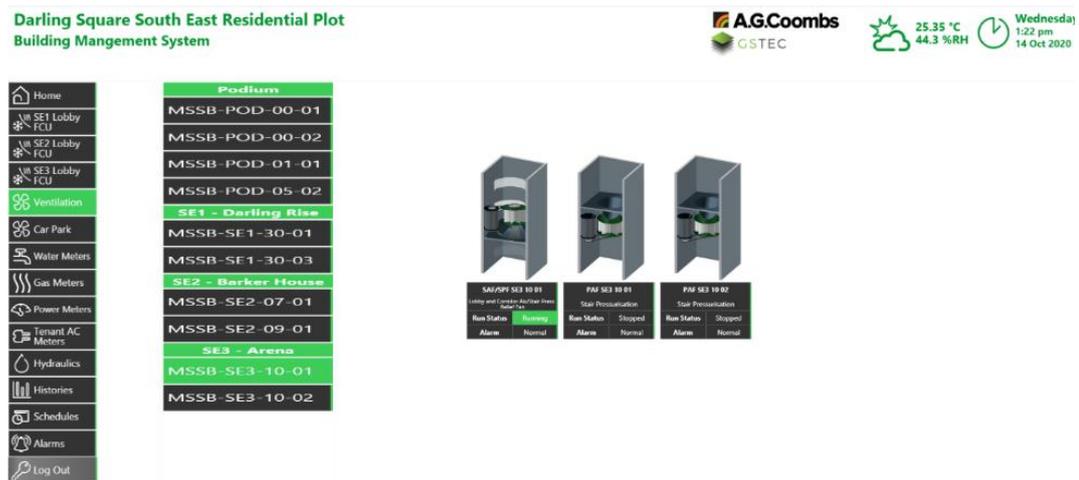
Concerns were raised in AR regarding no fresh in the corridors. Building Management investigated the issues with the building management system (BMS) contractors GS-Tech.

After GS-Techs investigation, the fresh air fan (SAF) had been set up correctly on the BMS. This has been rectified and the fan has been programmed to run 24/7 as designed. This allows fresh air into the corridors at all hours.

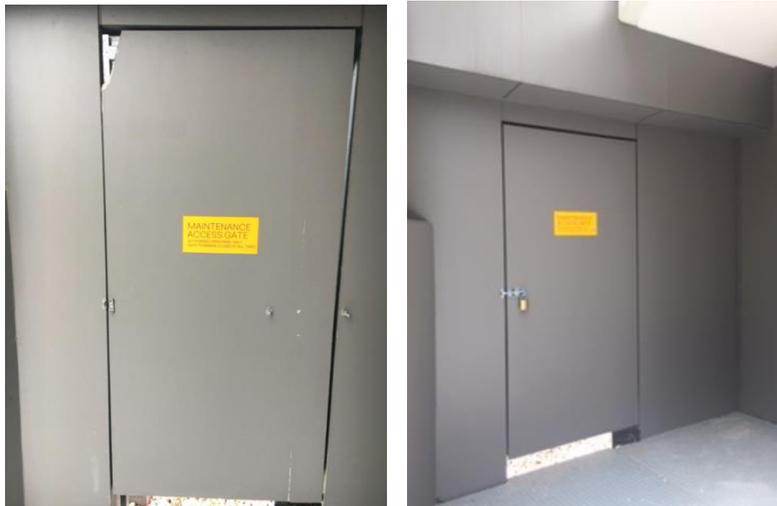
General maintenance continues to be completed. These works are picked up on the BM's daily walks and completed by the handyman. The pool equipment door situation behind the swimming pool has been rehung, repaired and painted by the handyman after being damaged due to faulty hinges.

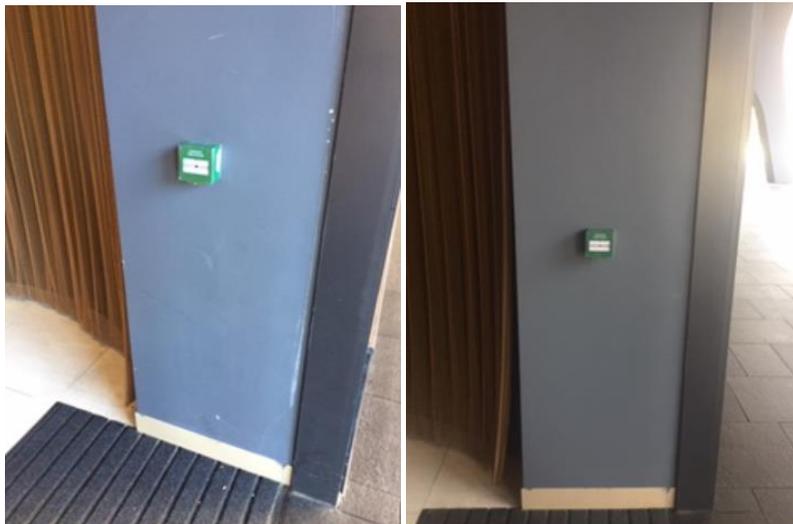
Darling Rise main entrance lobby walls patched and painted.

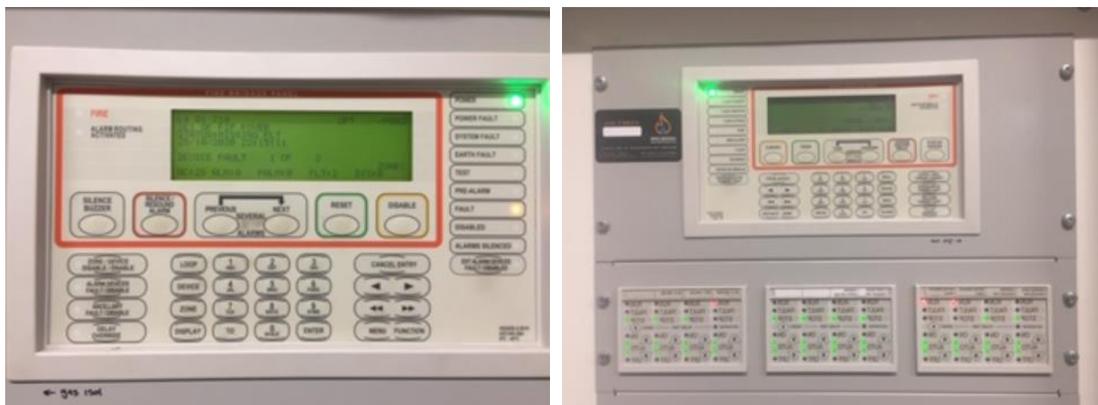
#### 4.3 FIP faults

The Fire Indication Panel (FIP) had detected faults in the following areas: Barker House Roof addressable strobe faulty, resident garbage room heat detector faulty and Darling Rise lobby heat detector faulty. All faulty equipment replaces and FIP reprogrammed. BM monitors the FIP on a daily basis.

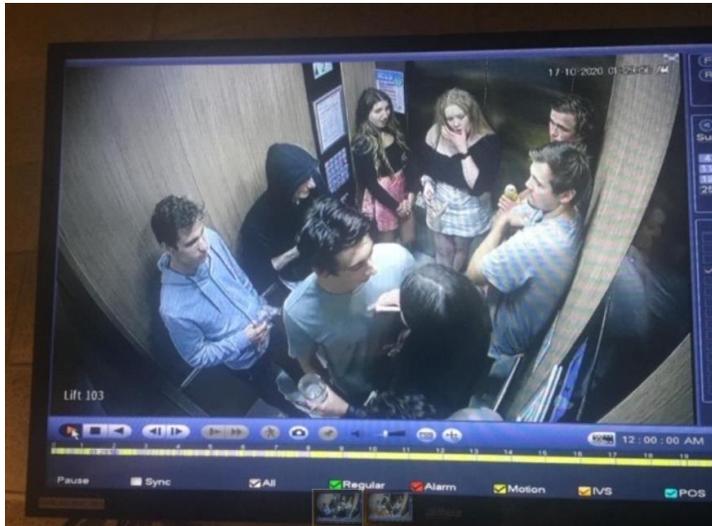
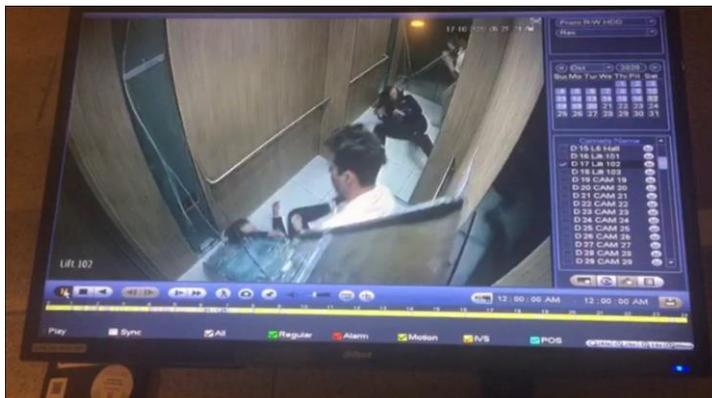
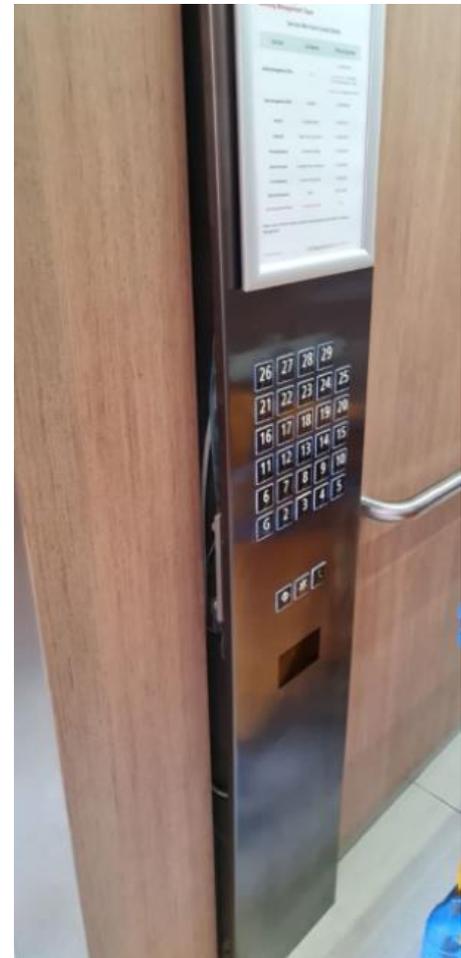
20/10/20 – AirBnB guests of lot 181 Darling Rise – Couple seen on CCTV fighting in lift, this caused damaged to the lift panel. Schindler were called to site on the afternoon of Sunday 20<sup>th</sup> October to fix the issue with a total cost of \$1360. Invoice will be charged back to unit 1901 once received.

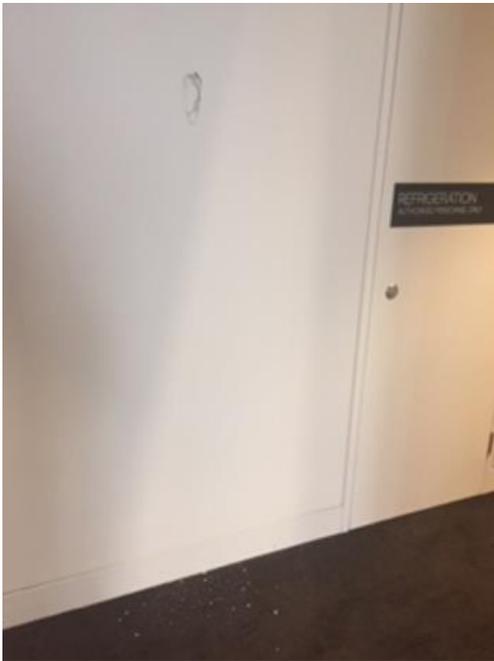
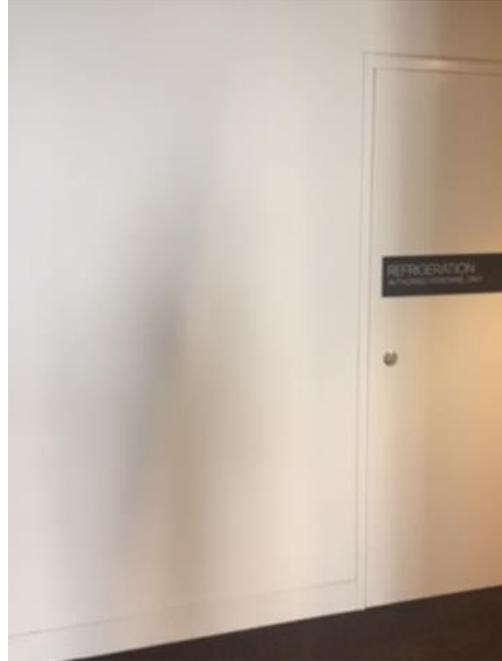
##### 4.5.1 Vandalism to 8<sup>th</sup> floor corridor wall

25/10/20 – Tenants of lot 56 Arena – Couple seen fighting on CCTV in level 8 corridor, this caused damage to the wall. The wall has been repaired by our handyman and \$330 charge back to the tenants.

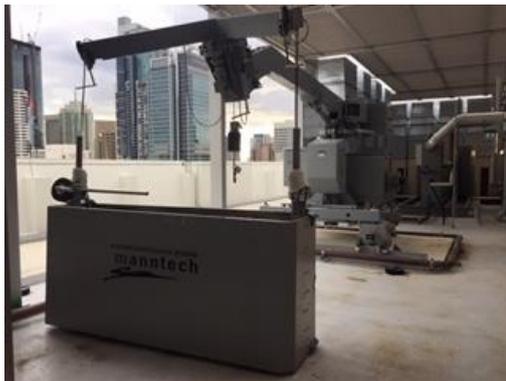
**Update:** The first BMU quarterly inspection and maintenance took place by GDP. The BMU passed all inspections with one outstanding issue regarding the emergency stop button. This will be quoted by GDP for rectification. An Adequate Maintenance Statement have been given to BM to apply for a plant registration certificate with Safe Work NSW.
