**DP1233930**

**Darling Square South East Plot  
Haymarket NSW 2000**

**February 2021**

**JLL Building Management  
Report**

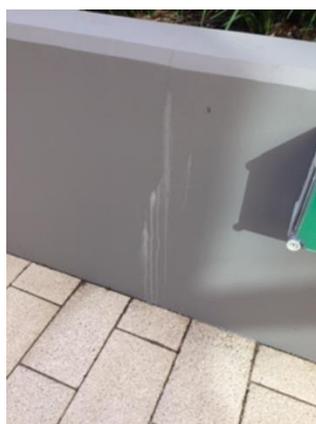
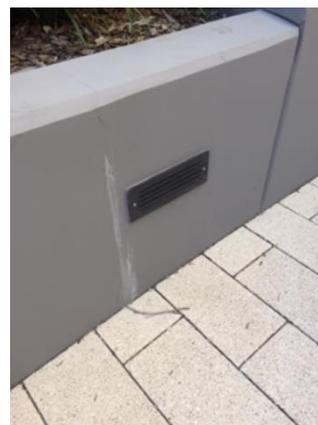
## 3.2 Total of 137 cracks identified in garden concrete walls on level 6 podium

Cracks in the garden walls were reported to Lend Lease who agreed the issue is defective. During build, the builders didn't insert enough control joints when the concrete pour occurred. With building movement this has caused the concrete to split more than it should. Hair line cracks have occurred close together as a result.

**Update:** Works have now been completed on Podium. Unfortunately it has been noticed by Building Management that efflorescent salts have started to penetrate the newly chasing and painted walls. The most recent response from LL is below:

Chasing (*A chase is a groove or channel cut into an existing layer or substrate to accommodate services such as pipes or cables. Chasing is the act of cutting a chase and is usually undertaken in solid wall or solid floor construction. 20mm wide and 20mm deep, filling with base filler*) is the method used by the builders in order to rectify the issue.

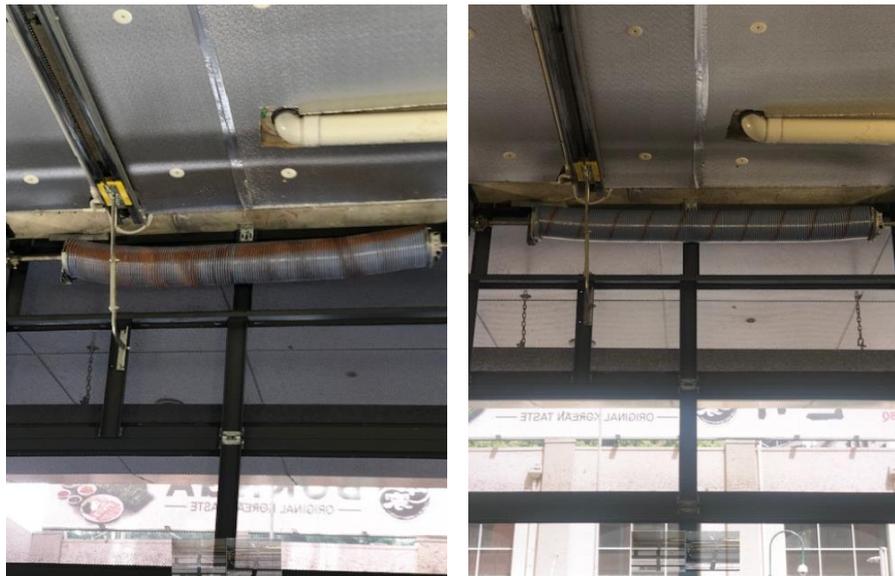
### 3.3 Roller Door break down – torsion bar replacement needed

The roller door broke down over the weekend of the 13<sup>th</sup> November. This took our contractors Allgate numerous attempts to fix the door due to an existing torsion bar that was fatigued. Due to the length of time and inconveniences it took to fix the torsion bar, Allgate replaced the torsion bar as a gesture of goodwill at a cost saving of \$2270. We have again had issues with the garage door torsion bar sagging. This causes a lot of noise and the door will eventually fall off its tracks. This was picked up by building management early enough to avoid this happening. Building Management engaged our garage door contractors Allgate who again have replaced the torsion bar free of charge, the works took place on 24/12/2020. The manufacturing manager at Allgate has overseen the manufacturing of the torsion bar to try and eradicate any of the issues we have experience over the past couple of months. We now have the second torsion bar booked in for replacement under warranty on 10/02/2021 which will be completed out of hours to minimize disruption to residents.

**Update:** Building Management have lodged the garage door as a defect with LendLease. The continuous break downs seem to be caused by the cycle rate which this door is not designed for. The gate has a cycle counter, we have used this information with documented job reports from our garage door contractors and have put a case together for LendLease requesting the door gets replaced for a more suitable design such as a roller door. We have provided factual evidence from industry professionals to assist us here.

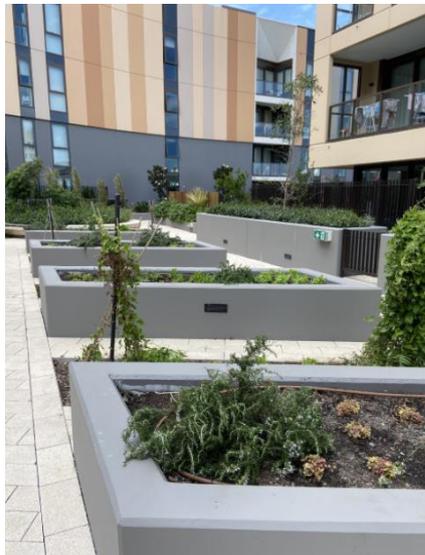
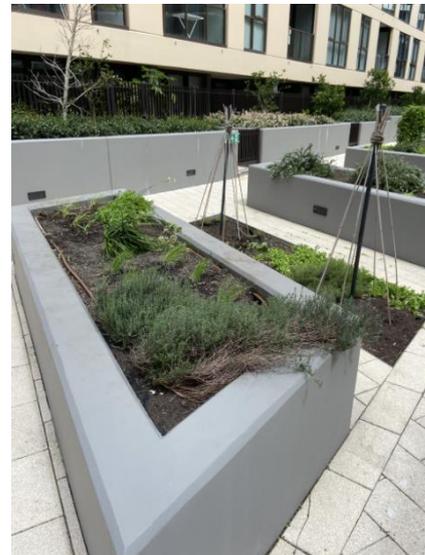
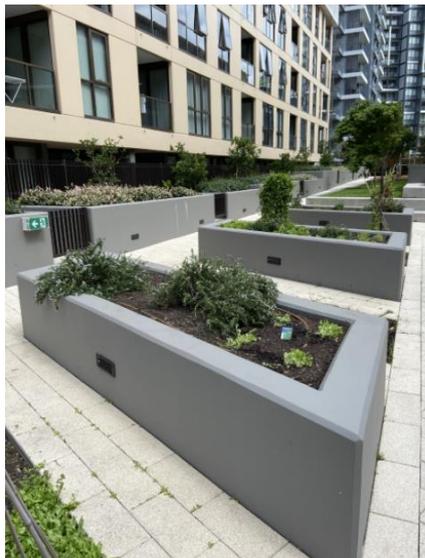
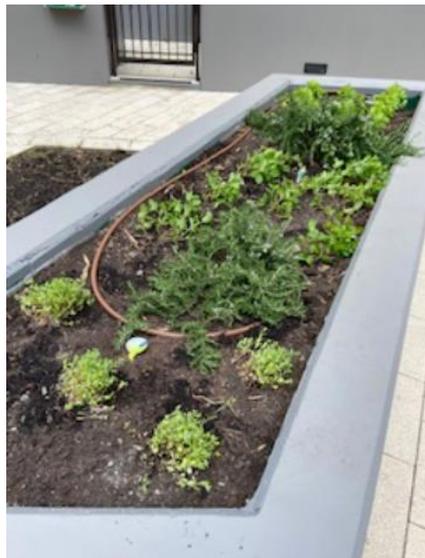
The resident vegetable patch has had a drainage issue in one of the pods. This has been rectified as part of a building defect through LendLease. The drainage system was blocked with construction debris (shown below) under the water proof membrane which caused the pod to flood. This has been left slightly muddy and BM have requested LL to top up with soil to avoid any additional mess. Now this has been fixed BM has acquired x3 quotes to replant herbs in the gardens to improve the look and cleanliness of the podium. The quotes are listed in section 6. To review at the next BMC.

**Update:** Works completed. Please see the above photos of the newly planted, much tidier resident herb garden. Building Management have had some great feedback from the residents who love the new gardens. We hope this brings more of a community feel to the podium community area for all residents to enjoy.

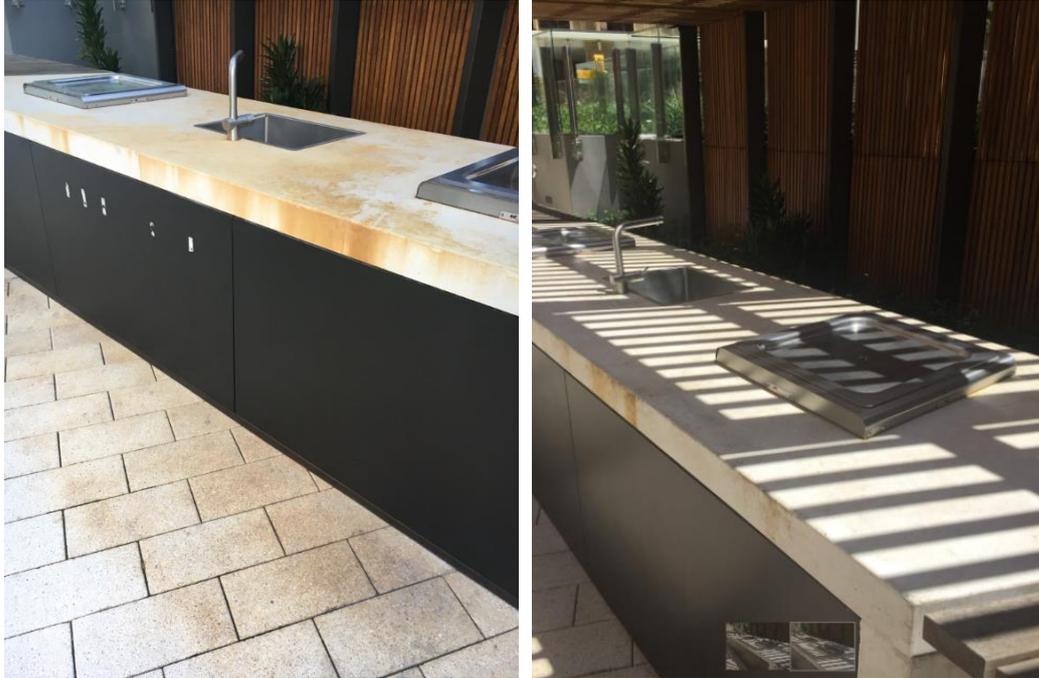
### 3.5 Staining in common BBQ area

Cleaning took place of the marble in the common BBQ area as shown in the photos below. This has been scheduled as a six monthly clean by our cleaners Dimeo with great results as seen in the below photos.

**Update:** BM has requested the wood be restrained to prevent future staining. This has been sent to LendLease as a defect.

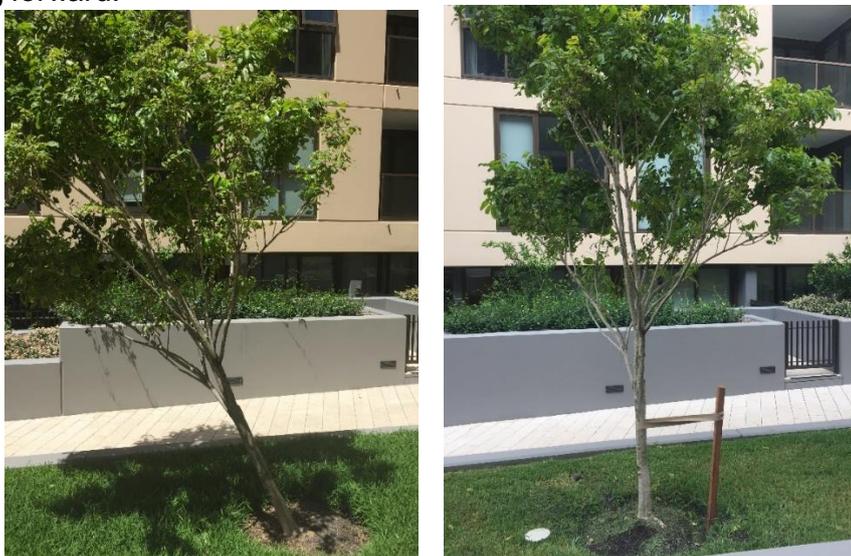
The podium tree was found to be unrooted and falling over. Landscape solutions attended site and re-rooted the tree and staked the tree as shown in the photos below. This is a high wind area, BM will monitor the trees and work with the Landscapers to resolve these issues moving forward.

**Update:** Completed, Building Management to monitor

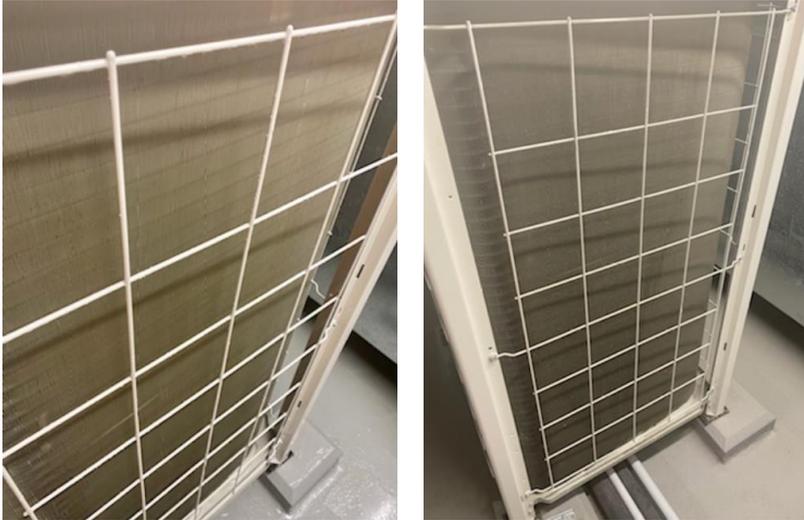
A clean of all the exterior HVAC units has taken place in the carpark due to the excessive amount of exhaust soot. This involved a chemical clean of the condenser coils and plant room areas. Moving forward this will be maintained on the quarterly servicing.

**Update:** Completed

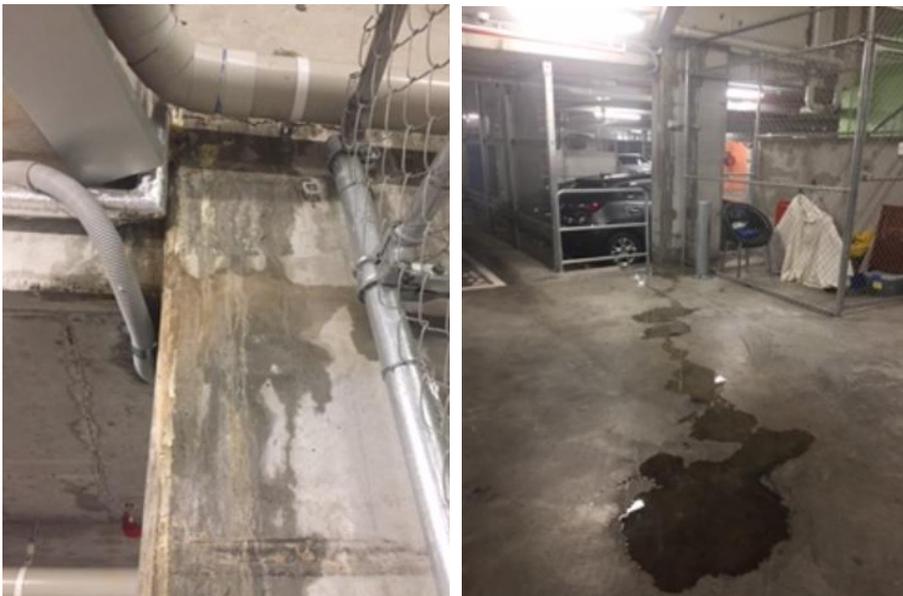
A leak was reported in the level 5 carpark on 29/01/2021. This appeared to be an existing leak which was logged as a defect with LL. This has again been forwarded onto LL as a defect and is being inspected by their onsite defects foreman to find a solution for the leak.

**Update:** Lendlease subcontractor Polyseal are waiting for a rain event to confirm where the water is entering. From this they can determine if the issue can be resolved by a further injection or another method to resolve this issue.

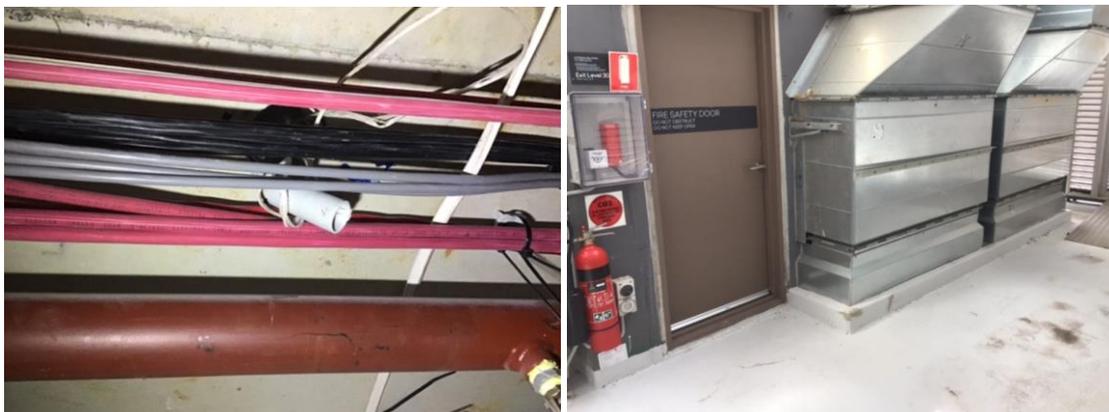
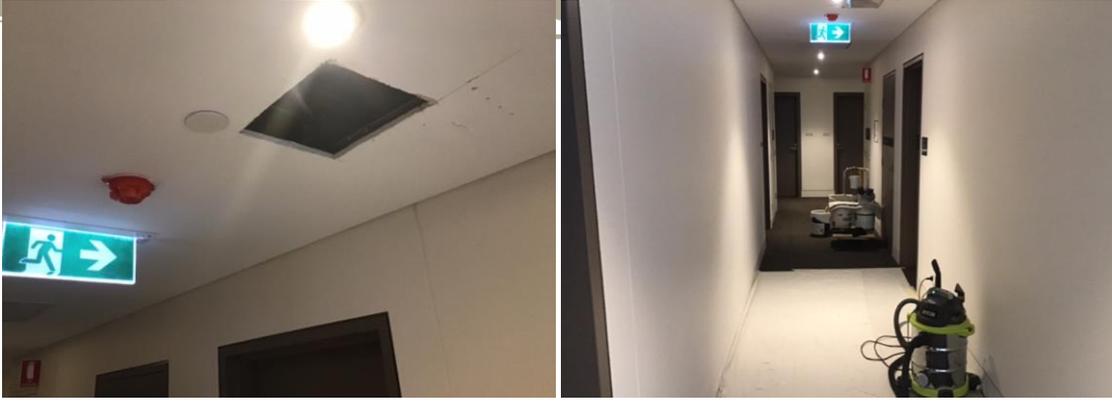
Due to the recent heavy rains in Sydney, leaks have appeared in the corridor on level 29. This has been forward onto Lendlease as a defect. They have since been onsite and cut an access hole on the ceiling in order to locate the leak. It seems it is coming through an unsealed pipe from level 30 plant room as shown in the below photos. This has now been sealed and will be tested to confirm the water proof sealant has worked.

**Update:** It seems the new water proof sealant has been successful with no leaks with the recent rain. Building Management and LendLease are currently monitoring this.

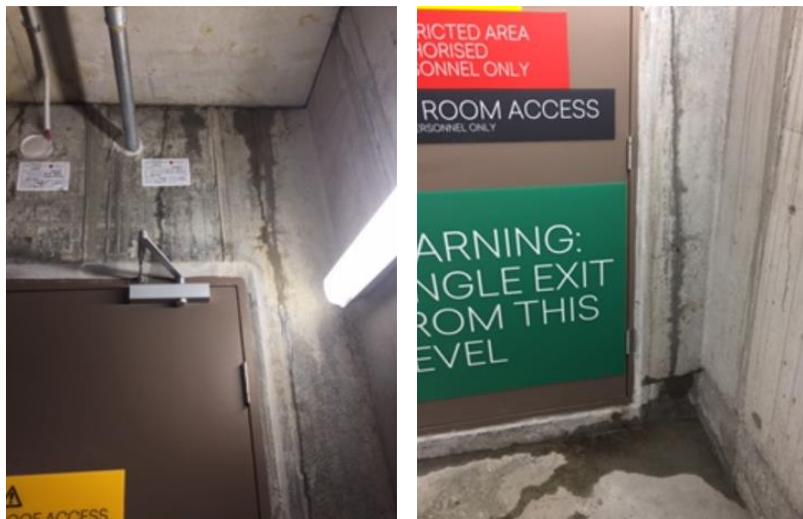
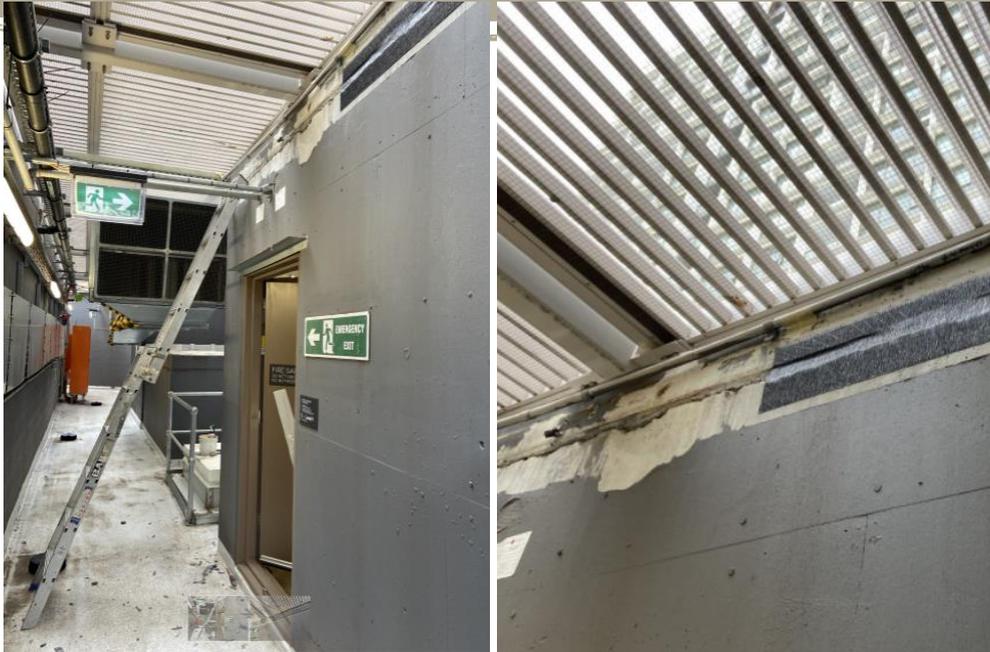
Due to the recent heavy rains in Sydney, leaks have appeared in fire escape staircase of Barker House. This has been forwarded onto Lendlease as a defect. They have since been onsite to monitor the leaks and plan to reseal the roof of the fire stairs.

**Update:** Lendlease have been onsite resealing the fire stairs roof. This will be monitored to see if thr waterproofing has been successful.

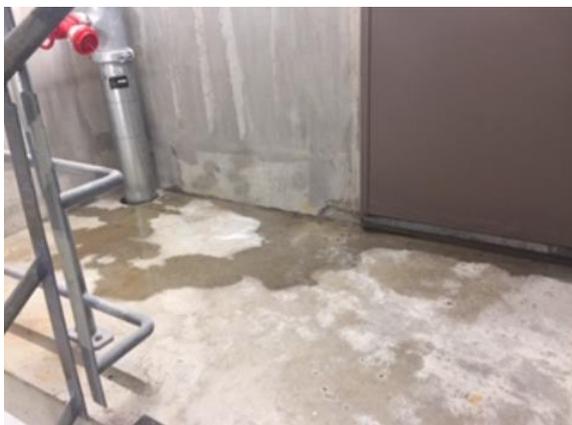
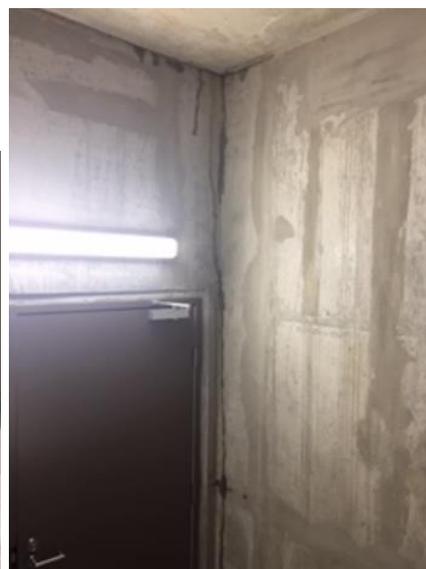
Due to the recent heavy rains in Sydney, leaks have appeared in fire escape staircase of Arena. This has been forwarded onto Lendlease as a defect. They have since been onsite to monitor the leaks and plan to reseal the roof of the fire stairs.

**Update:** Lendlease have been onsite resealing the fire stairs roof. This will be monitored to see if thr waterproofing has been successful.

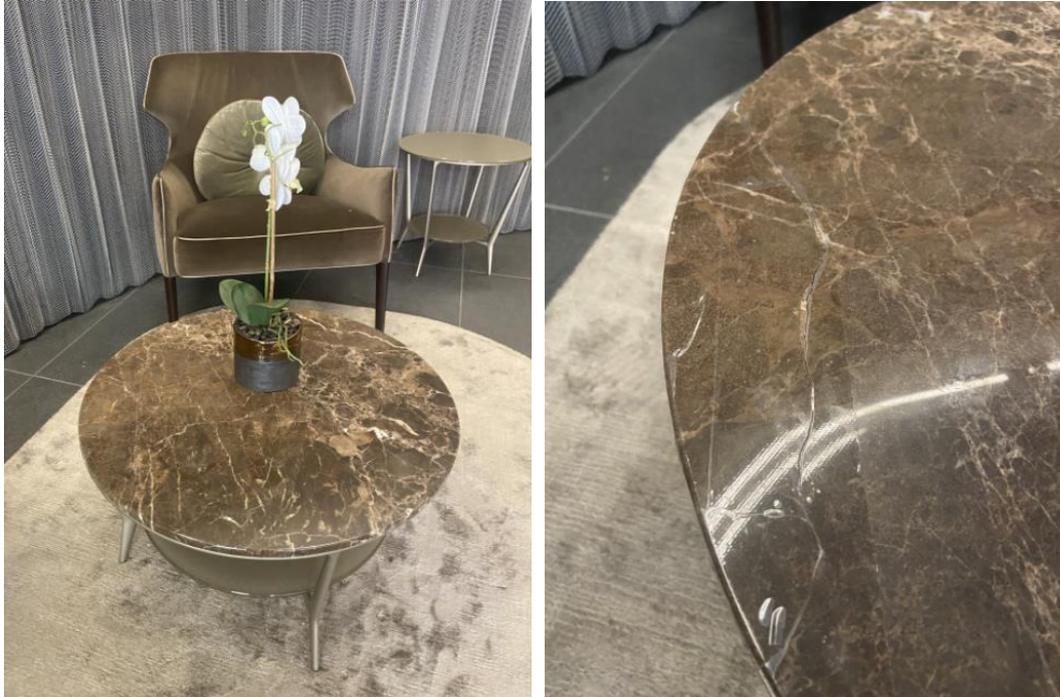
The lobby table was found to be damaged on 05/01/2021. When investigated on the CCTV by Building Management, an intoxicated resident was seen to kick and crack the marble table. The table was a gift from LL and worth \$3695. The table has been reordered and invoiced back to the resident responsible.

**Update:** The resident from Lot 24 has admitted fault, a payment plan has been set up with the manufacturer Rimadesio. The first two payments has been successfully paid.

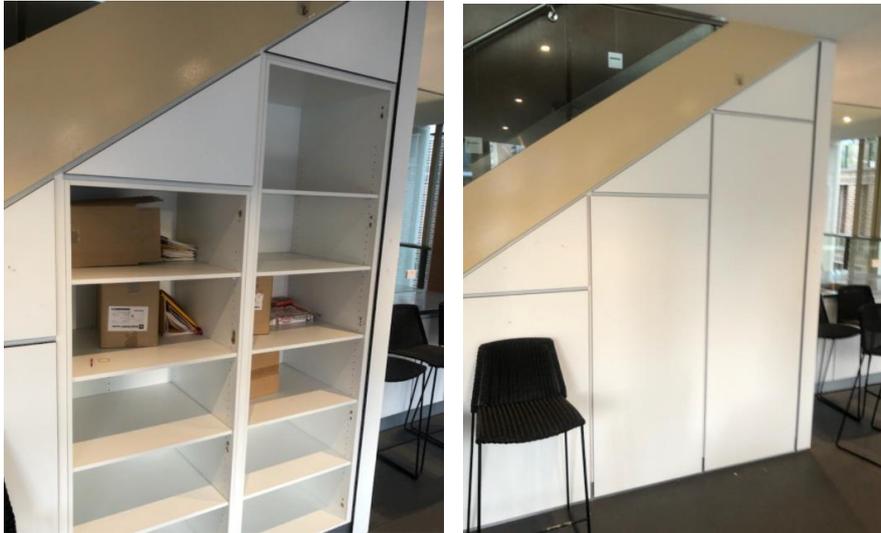
The podium common area doors have been repaired after the hinges broke. Please see photos below. Different hinges have been installed which will hold the weight of the doors better and prevent this from happening again.

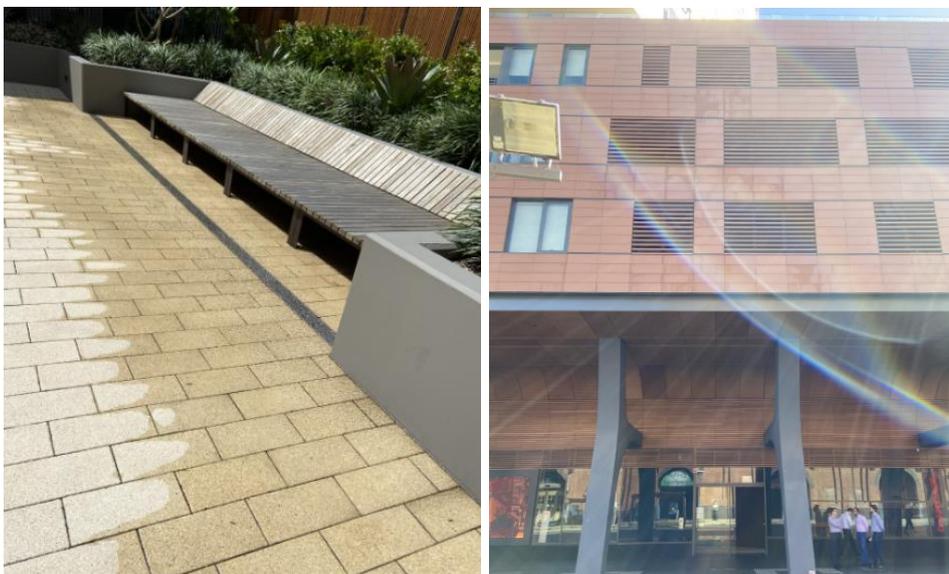
Building Management noticed water over spilling from Arena balconies onto Little Hay Street. When investigated, it was found to be a blocked storm water drain on the podium. Building Management called out the resident plumber who cleared the blockage.

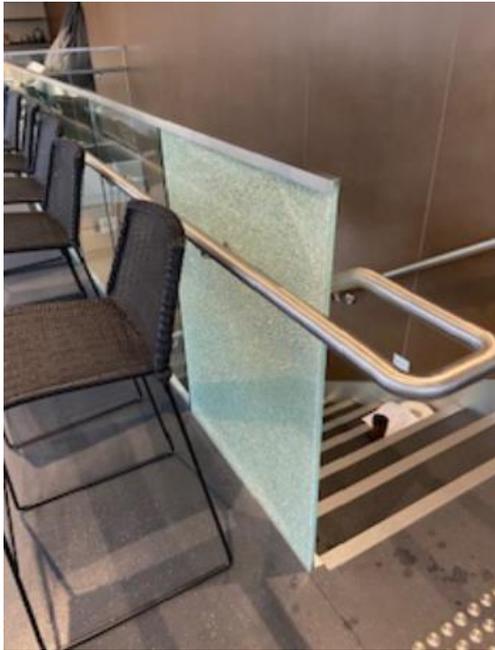
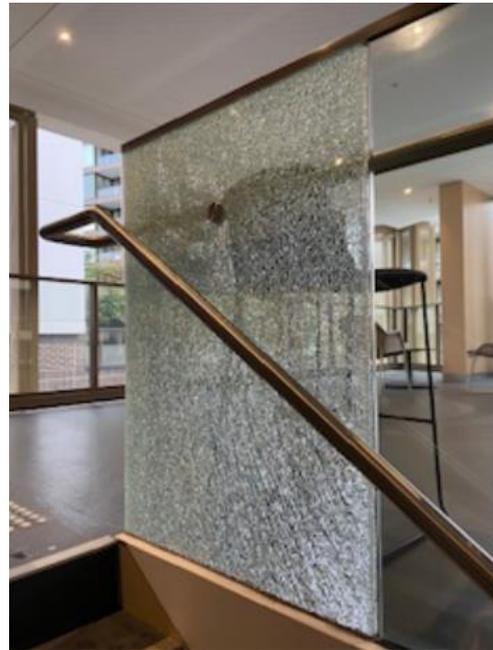
The cleaners reported a smashed pane of glass in the level 7 floor common area. Building Management investigated the incident on the CCTV footage which showed the glass spontaneously exploding. The glass is safety glass and stayed in situ, the area has however been closed off as an extra precaution.

This has been sent and accepted by LendLease as a defect. The glass has been measured by the installer and there looks to be a two week lead time on manufacturing before it can be replaced.

Unfortunately, until the glass is replaced level 7 floor common area will remain closed for H&S reasons.

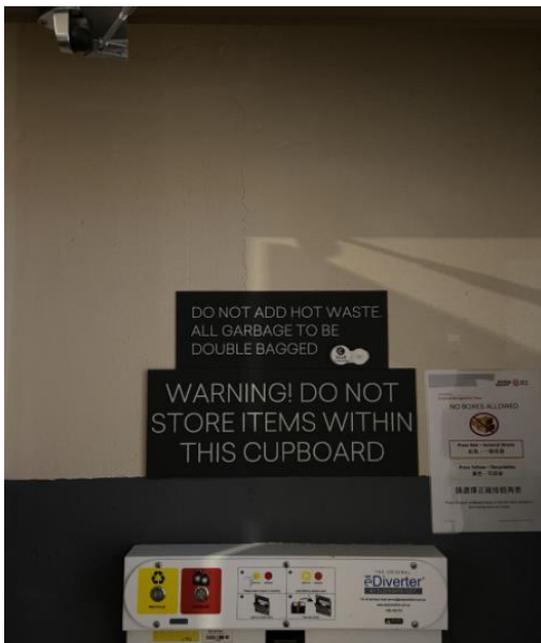
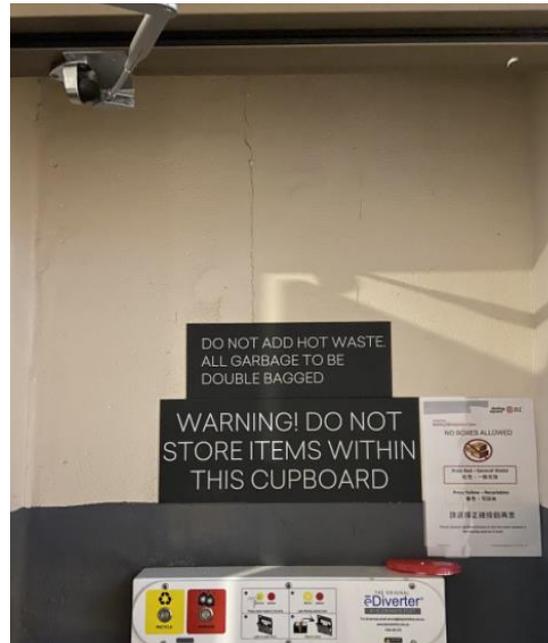
Building Management have found cracks in the refuse chutes on 11 floors of Darling Rise whilst completing daily property walks. The crack were found on levels; 3, 6, 11, 15, 17, 18, 20, 22, 24, 27 & 28. This has been reported to LendLease as a defect.

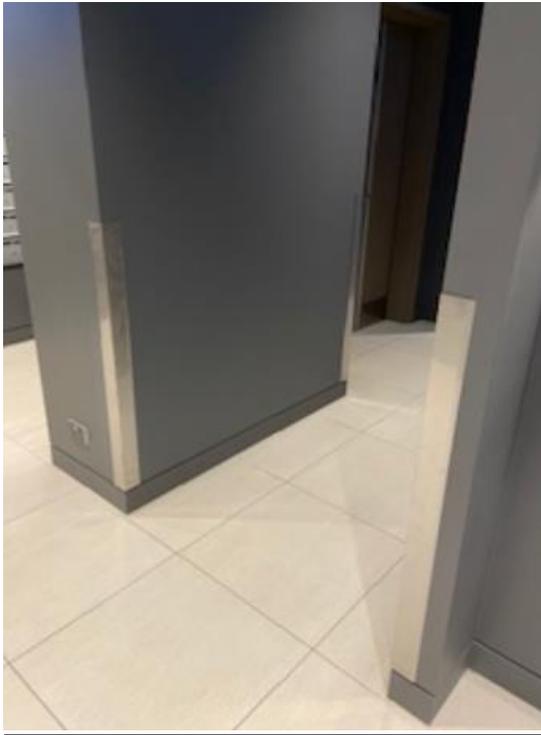
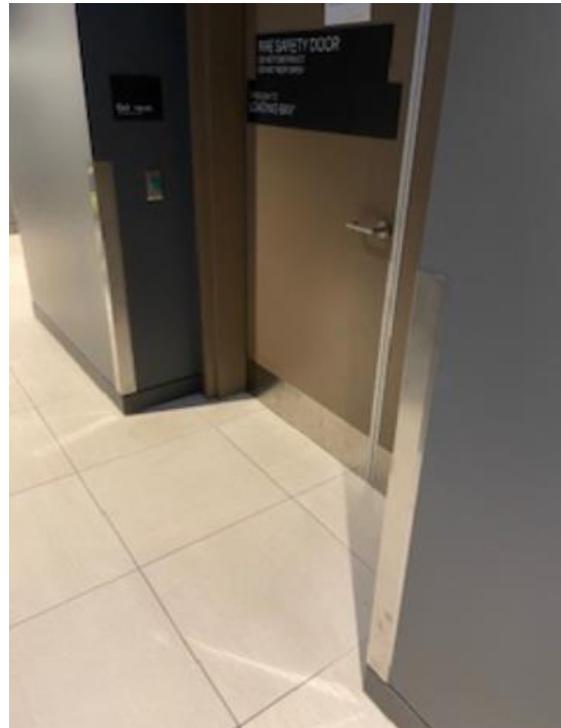
The resident handy man has been onsite painting the corridor leading from the lobby to the loading dock in Darling Rise. Due to the high amount of traffic in this area, stainless steel strips have been placed on all corners to sustain the paintwork and general upkeep of the walls. We hope this will protect common property and save money moving forward.

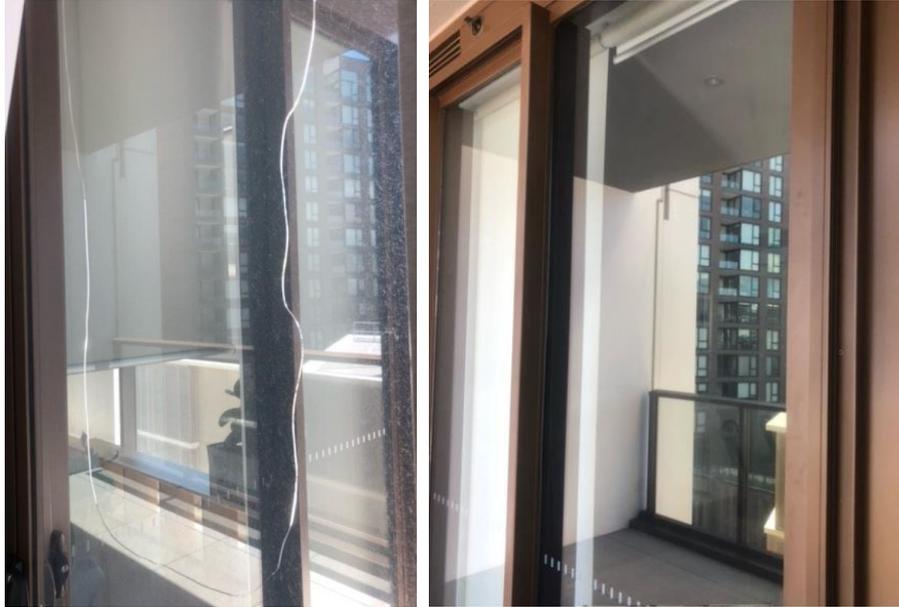
Lot 87 reported a cracked pane of glass on the balcony door as shown in the photos below. Two quotes were obtained and the crack was confirmed as a heat fracture. The window was replaced successfully by the contractor who provided the cheapest quote.

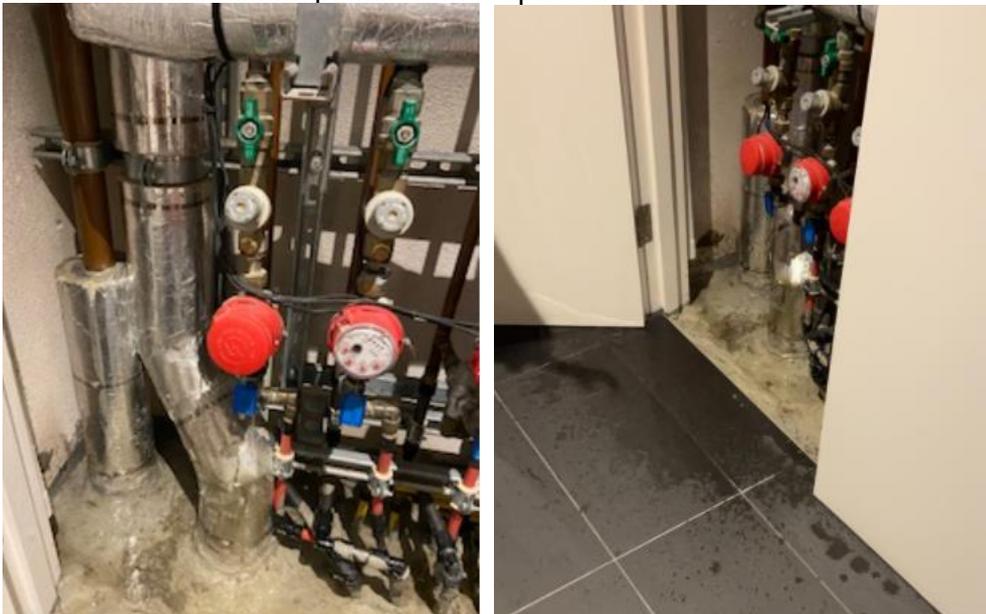
Water was noticed coming from the water services cupboard on level 6 of Arena. The hot water meter seals had failed causing a hot water leak. Building management isolated the leak and called out the resident plumber who replaced the seal.
