**Darling Square South East Plot  
Haymarket NSW 2000**

**March 2021**

**JLL Building Management  
Report**

**Date of Report: 15<sup>th</sup> April 2021**

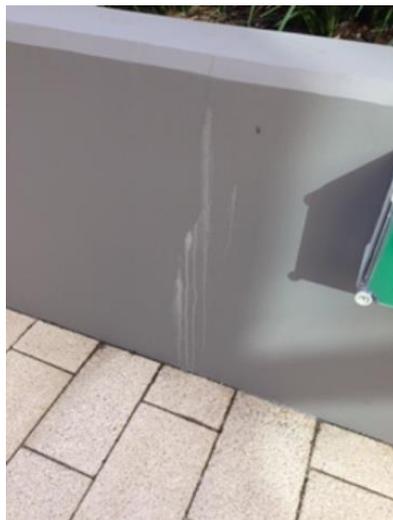
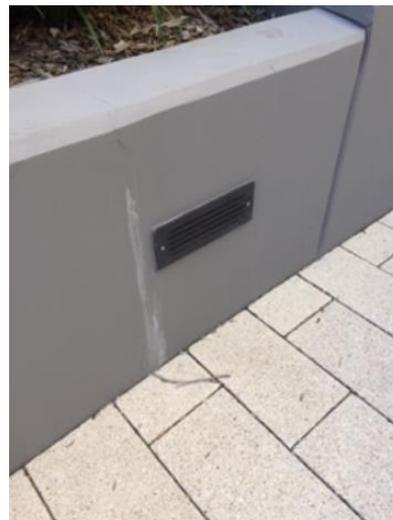
## **3.2 Total of 137 cracks identified in garden concrete walls on level 6 podium**

Cracks in the garden walls were reported to Lend Lease who agreed the issue is defective. During build, the builders didn't insert enough control joints when the concrete pour occurred. With building movement this has caused the concrete to split more than it should. Hair line cracks have occurred close together as a result.

**Update:** LendLease have subcontractors onsite 19<sup>th</sup> – 23<sup>rd</sup> April to complete the second lot of remedial works to the podium walls.

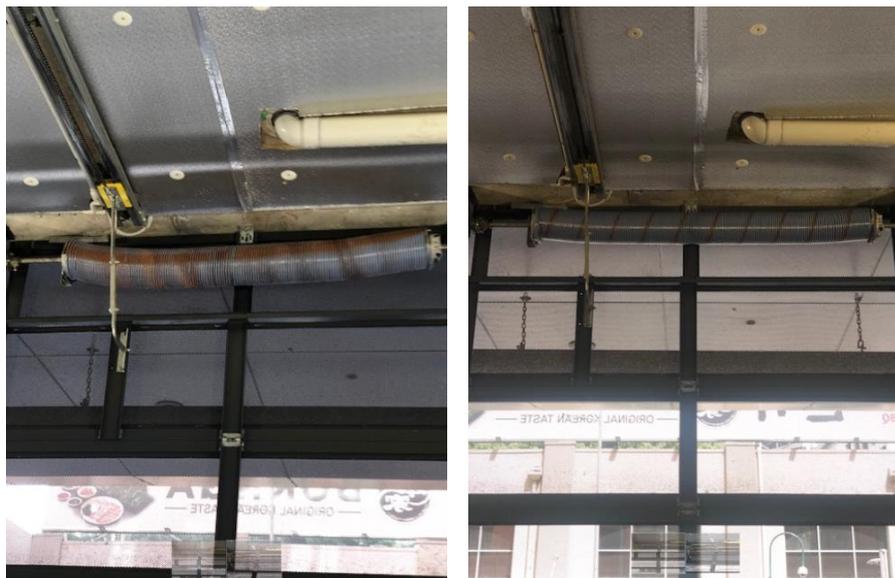
The roller door broke down over the weekend of the 13<sup>th</sup> November. This took our contractors Allgate numerous attempts to fix the door due to an existing torsion bar that was fatigued. Due to the length of time and inconveniences it took to fix the torsion bar, Allgate replaced the torsion bar as a gesture of goodwill at a cost saving of \$2270. We have again had issues with the garage door torsion bar sagging. This causes a lot of noise and the door will eventually fall off its tracks. This was picked up by building management early enough to avoid this happening. Building Management engaged our garage door contractors Allgate who again have replaced the torsion bar free of charge, the works took place on 24/12/2020. The manufacturing manager at Allgate has overseen the manufacturing of the torsion bar to try and eradicate any of the issues we have experience over the past couple of months. We now have the second torsion bar booked in for replacement under warranty on 10/02/2021 which will be completed out of hours to minimize disruption to residents.

**Update:** Building Management have lodged the garage door as a defect with LendLease. The continuous break downs seem to be caused by the cycle rate which this door is not designed for. The gate has a cycle counter, we have used this information with documented job reports from our garage door contractors and have put a case together for LendLease requesting the door gets replaced for a more suitable design such as a roller door or gate. We have provided factual evidence from industry professionals to assist us here.

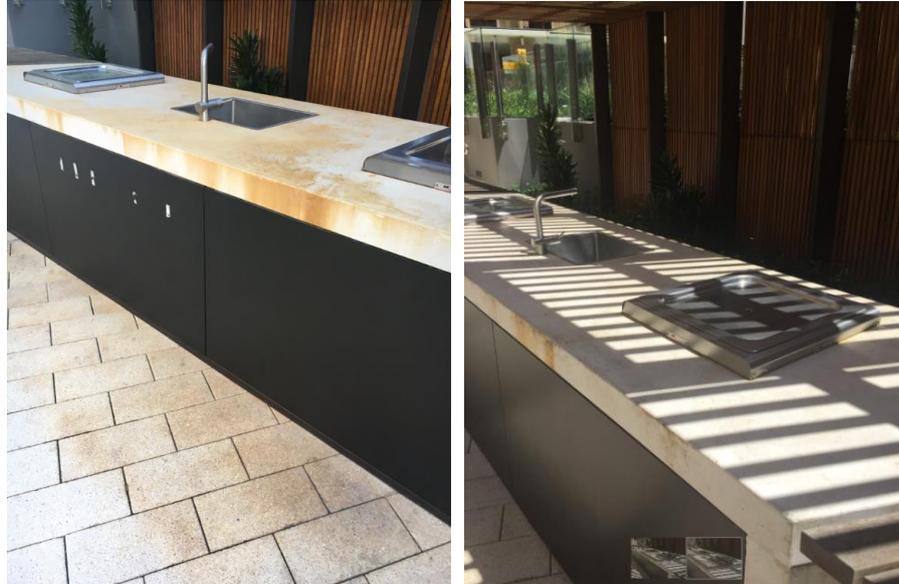
Cleaning took place of the marble in the common BBQ area as shown in the photos below. This has been scheduled as a six monthly clean by our cleaners Dimeo with great results as seen in the below photos.

**Update:** BM has requested the wood be restrained to prevent future staining. This has been sent to LendLease as a defect.

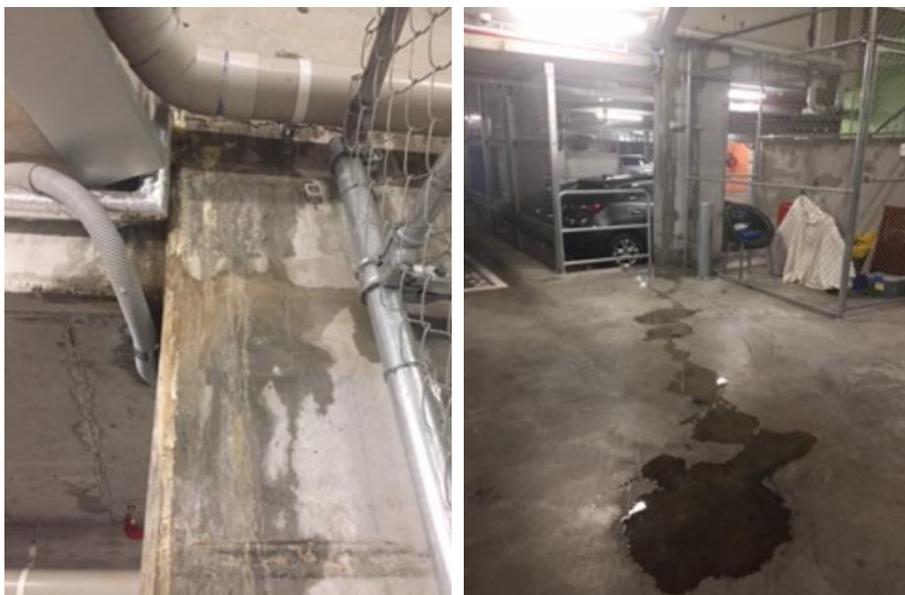
A leak was reported in the level 5 carpark on 29/01/2021. This appeared to be an existing leak which was logged as a defect with LL. This has again been forwarded onto LL as a defect and is being inspected by their onsite defects foreman to find a solution for the leak.

**Update:** Lendlease subcontractors Polyseal attended site on the 23<sup>rd</sup> March for further waterproofing of a previous leak. This included waterproof injections to the concrete slabs

and resituating of the drips trays which were recently installed. Building Management will monitor this leak moving forward.

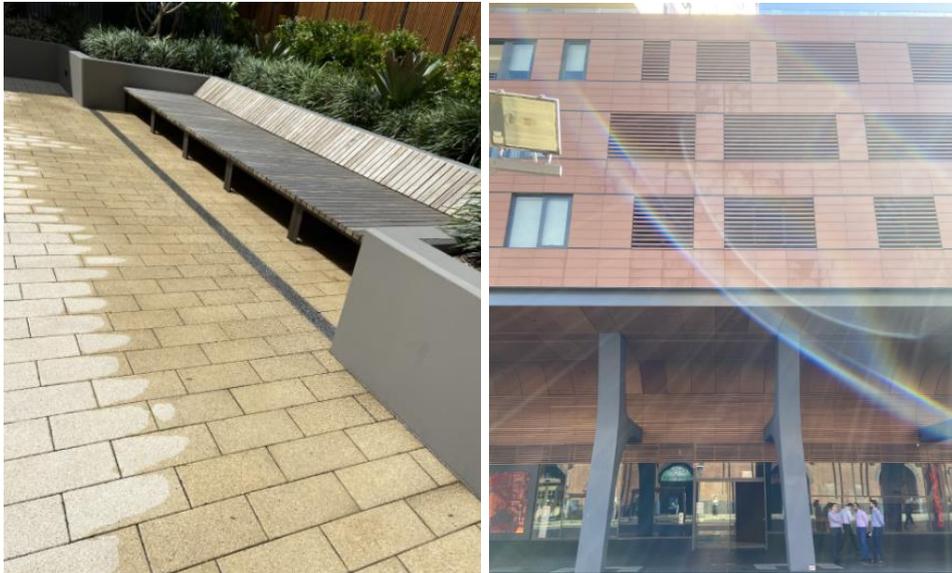
Building Management noticed water over spilling from Arena balconies onto Little Hay Street. When investigated, it was found to be a blocked storm water drain on the podium. Building Management called out the resident plumber who cleared the blockage.

**Update:** Works completed. The resident plumber has since been onsite to further jet the blocked storm water drain to prevent further floods.

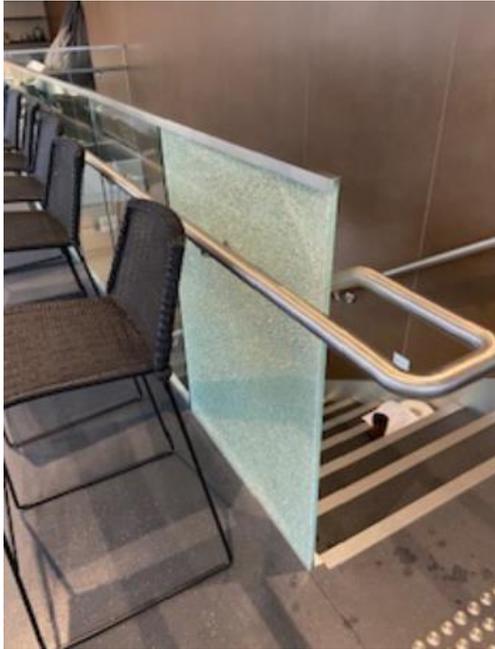
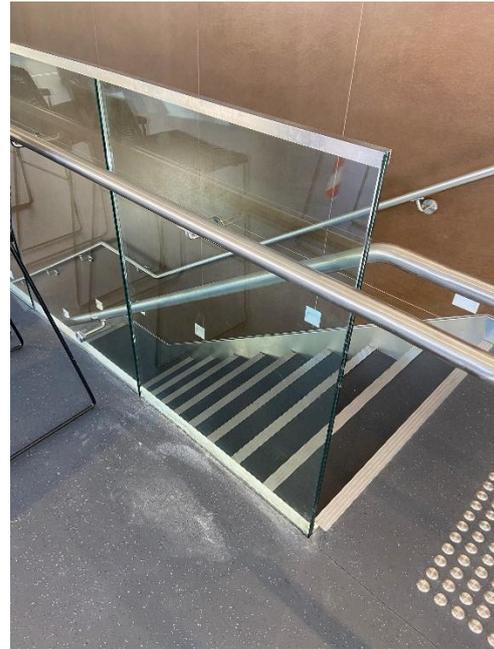
The cleaners reported a smashed pane of glass in the level 7 floor common area. Building Management investigated the incident on the CCTV footage which showed the glass spontaneously exploding. The glass is safety glass and stayed in situ, the area has however been closed off as an extra precaution.

This has been sent and accepted by LendLease as a defect. The glass has been measured by the installer and there looks to be a two week lead time on manufacturing before it can be replaced.

**Update:** Works completed under DLP through LendLease

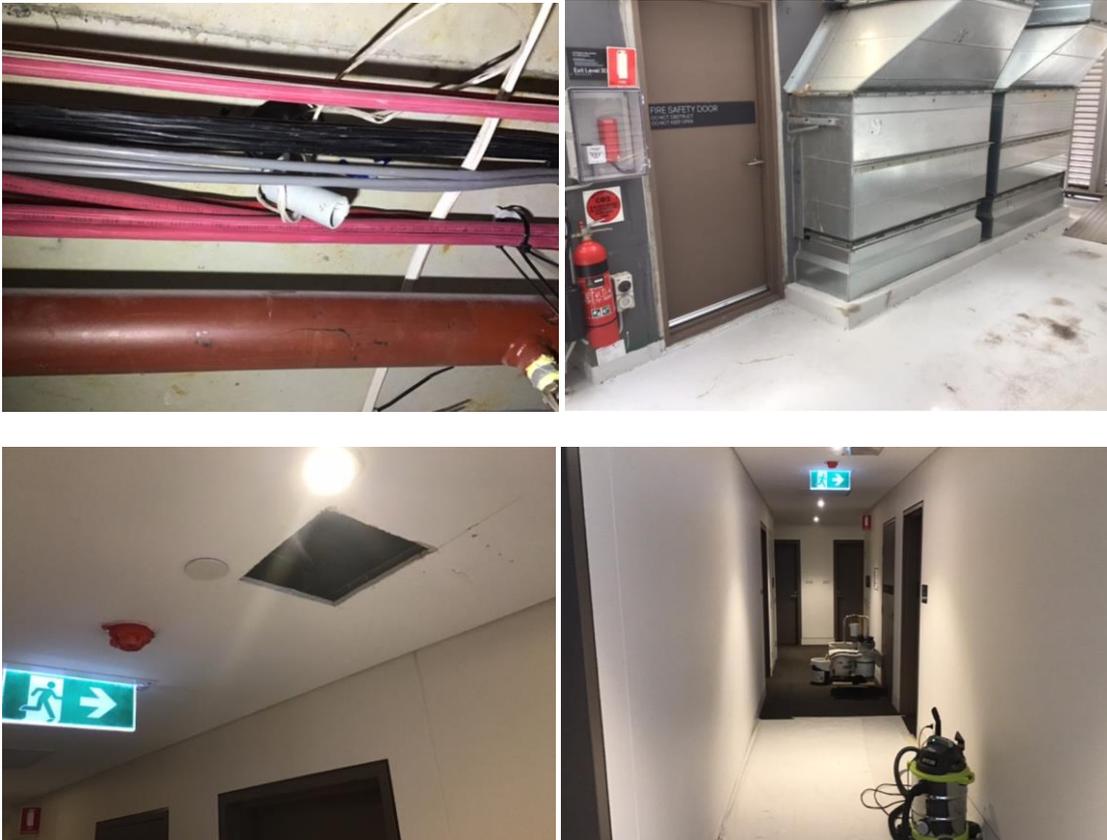
Due to the recent heavy rains in Sydney, leaks have appeared in the corridor on level 29. This has been forward onto Lendlease as a defect. They have since been onsite and cut an access hole on the ceiling in order to locate the leak. It seems it is coming through an unsealed pipe from level 30 plant room as shown in the below photos. This has now been sealed and will be tested to confirm the water proof sealant has worked.

**Update:** Works completed under DLP through LendLease

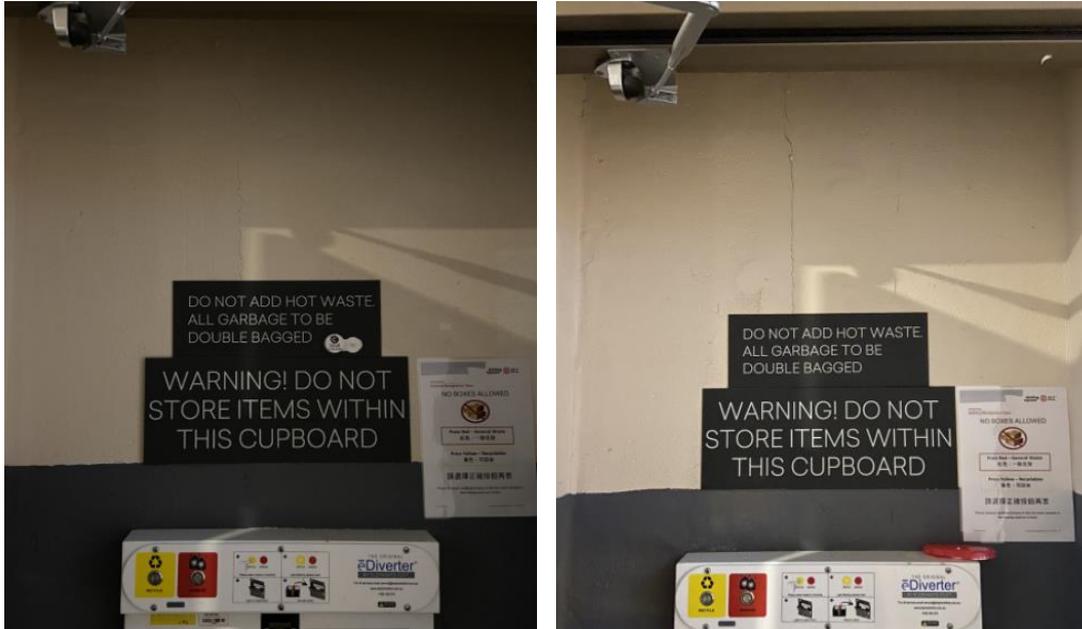
Building Management have found cracks in the refuse chutes on 11 floors of Darling Rise whilst completing daily property walks. The crack were found on levels; 3, 6, 11, 15, 17, 18, 20, 22, 24, 27 & 28. This has been reported to LendLease as a defect.

**Update:** Level 28 has been completed. Awaiting a response from LendLease for the remaining cracks.

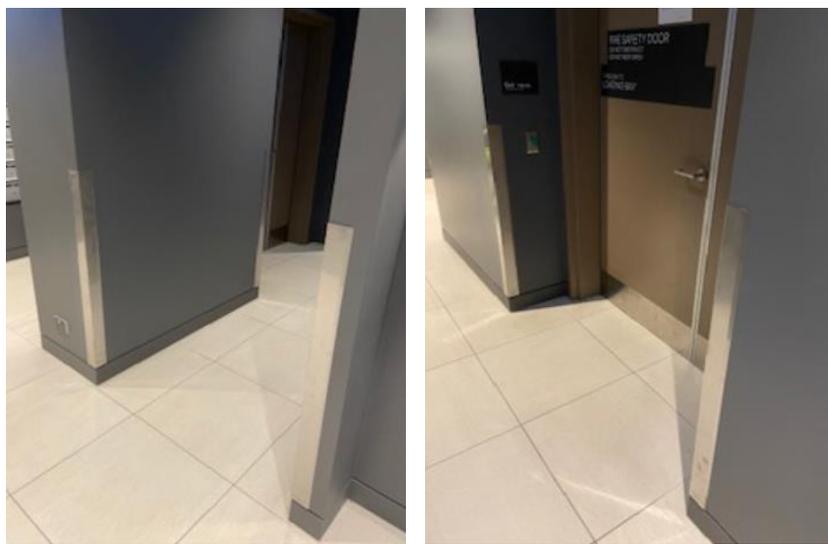
The resident handy man has been onsite painting the corridor leading from the lobby to the loading dock in Darling Rise. Due to the high amount of traffic in this area, stainless steel strips have been placed on all corners to sustain the paintwork and general upkeep of the walls. We hope this will protect common property and save money moving forward.

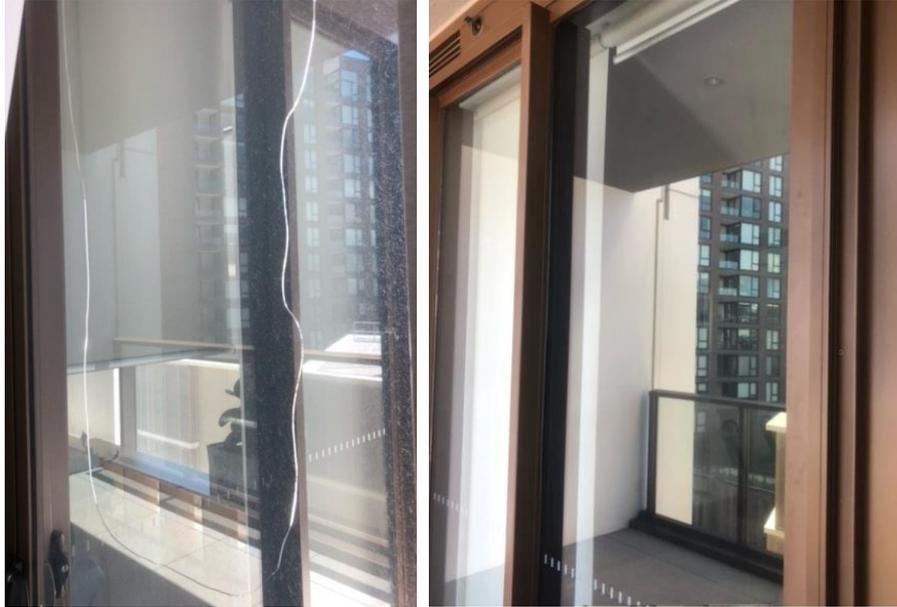
Lot 87 reported a cracked pain of glass on the balcony door as shown in the photos below. Two quotes were obtained and the crack was confirmed as a heat fracture. The window was replaced succesfully by the contractor who provided the cheapest quote.

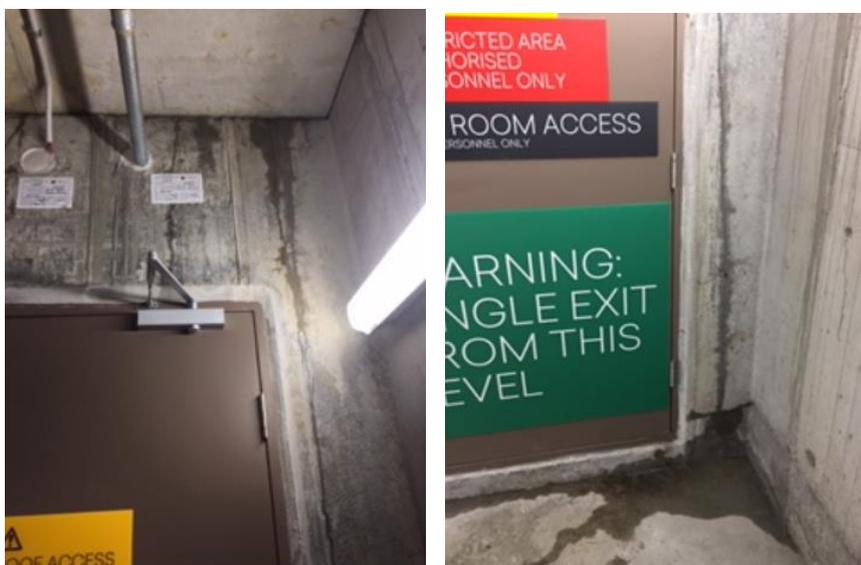
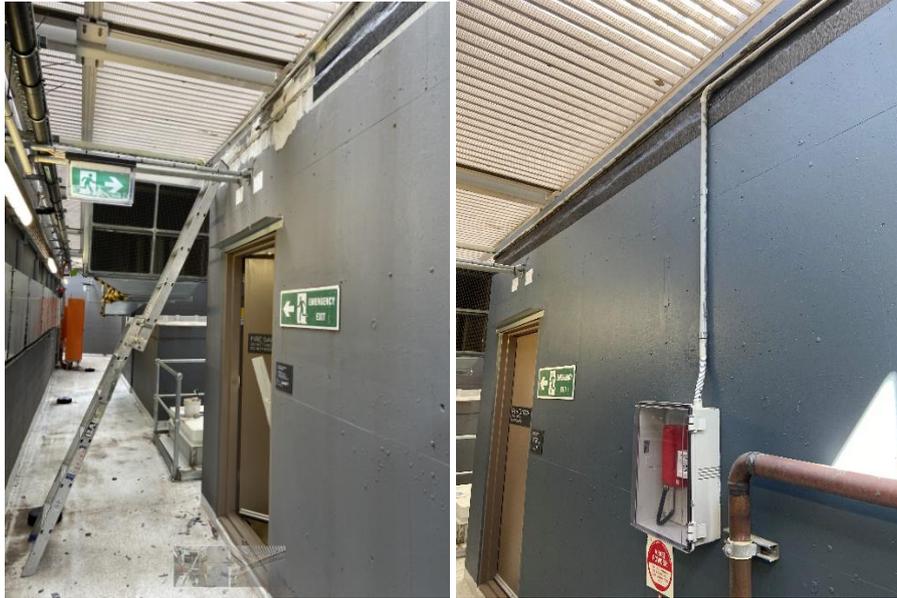
Due to the recent heavy rains in Sydney, leaks have appeared in fire escape staircase of Barker House. This has been forwarded onto Lendlease as a defect. They have since been onsite to monitor the leaks and plan to reseal the roof of the fire stairs.

**Update:** Lendlease have been onsite resealing the fire stairs roof. This will be monitored to see if the waterproofing has been successful. Patching to the paintwork has also taken place.

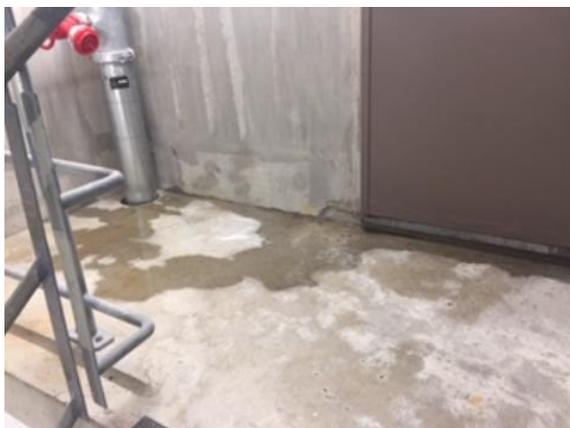
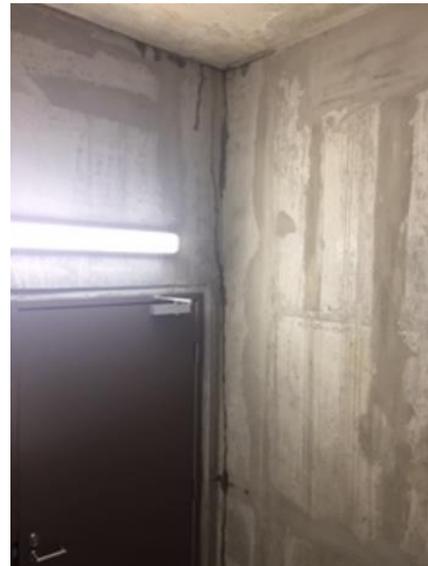
Due to the recent heavy rains in Sydney, leaks have appeared in fire escape staircase of Arena. This has been forwarded onto Lendlease as a defect. They have since been onsite to monitor the leaks and plan to reseal the roof of the fire stairs.

**Update:** Lendlease have been onsite resealing the fire stairs roof. This will be monitored to see if the waterproofing has been successful.

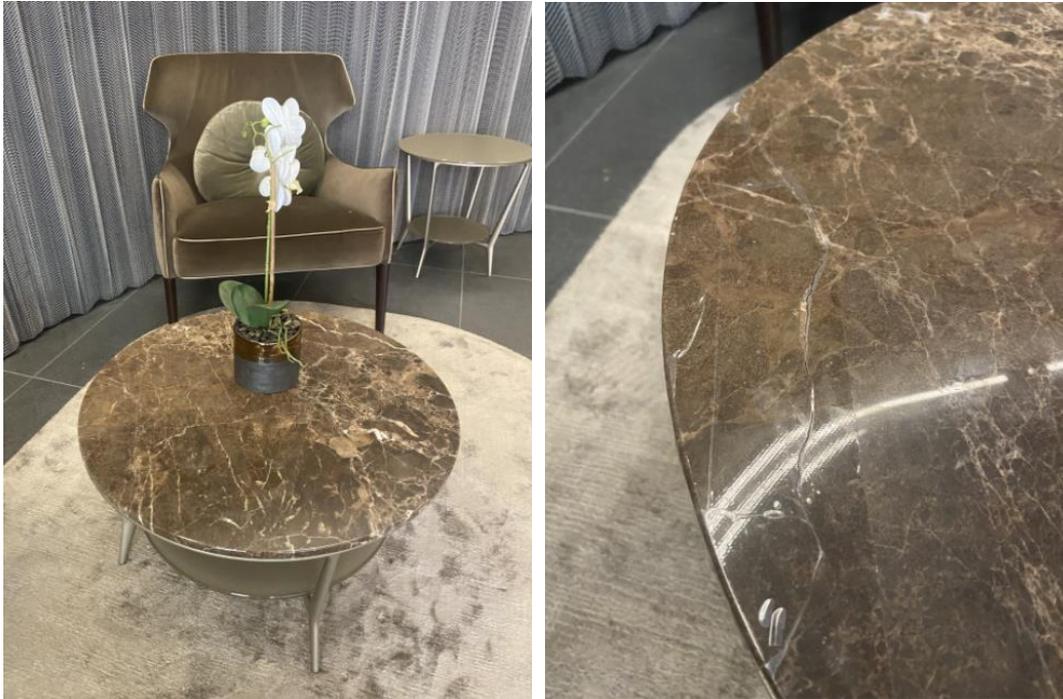
The lobby table was found to be damaged on 05/01/2021. When investigated on the CCTV by Building Management, an intoxicated resident was seen to kick and crack the marble table. The table was a gift from LL and worth \$3695. The table has been reordered and invoiced back to the resident responsible.

**Update:** The resident from Lot 24 has admitted fault, a payment plan has been set up with the manufacturer Rimadesio. The first two payments has been successfully paid.

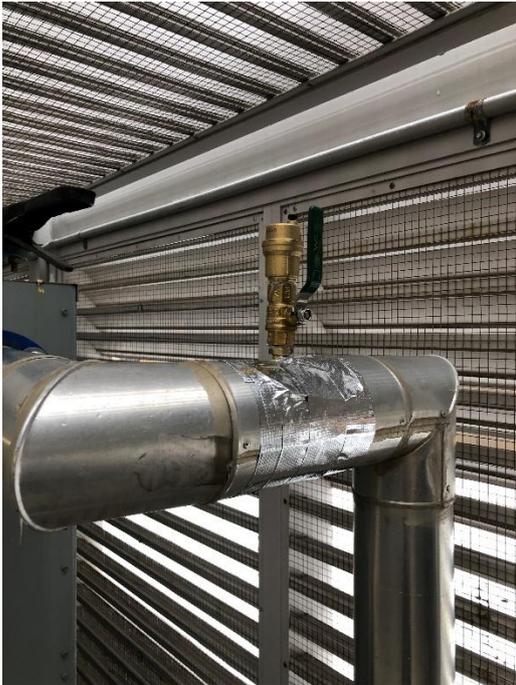
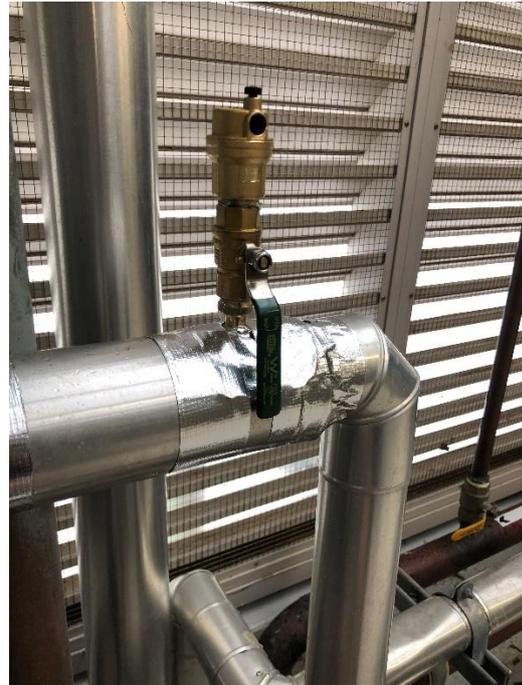
It was reported to Building Management on Saturday 23/01/2021 that there were several units in Arena with no hot water. The resident plumber was called on an emergency service call. It was found there was an air lock in the hot water circulation pumps situated in the plant room. This may have been caused by the works which took place on the irrigation pumps when the mechanical seal got replaced, due to air getting into the system. As this is the highest point of the building, the air locks caused the pumps to shut off as a safety precaution to prevent them from running dry and causing further damage.

To prevent this from happening in future, Building Management are currently working with the resident plumber to install air release valves in the plant room, at the highest point of the hot water system. If works are to take place on the system where there is a chance of an air lock happening, the valve will atomically release any airlocks preventing any problems in the hot water systems.

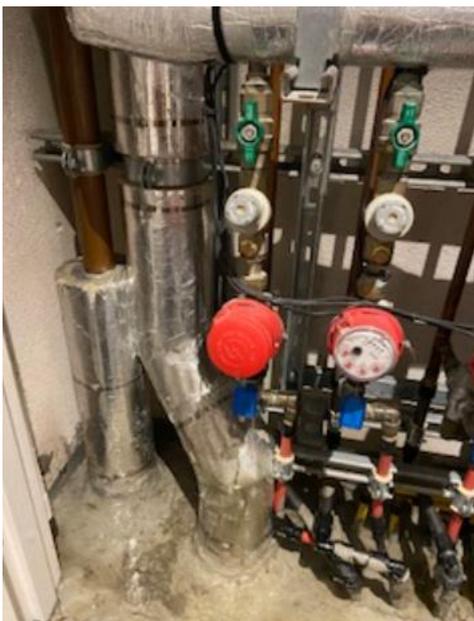
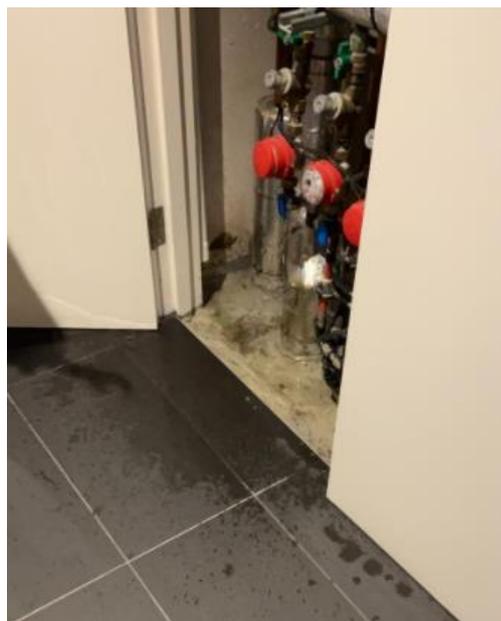
Water was noticed coming from the water services cupboard on level 6 of Arena. The hot water meter seals had failed causing a hot water leak. Building management isolated the leak and called out the resident plumber who replaced the seal.

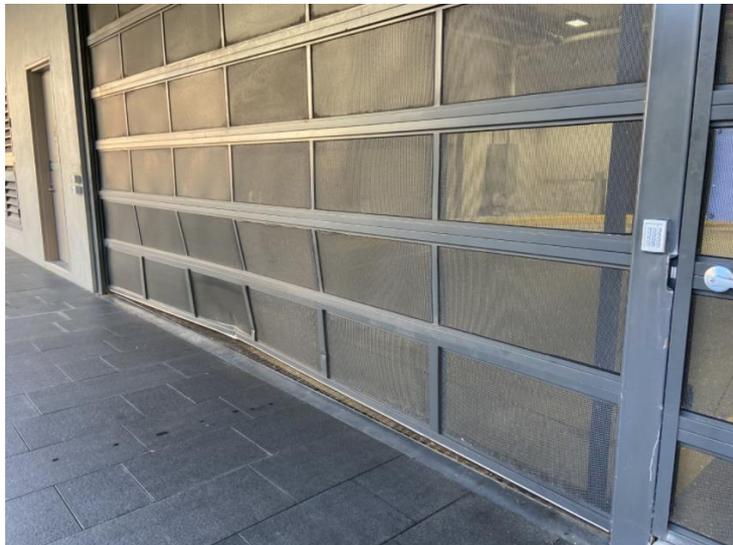
An incident with the garage door took place on the 08/03 when a delivery driver hit the bottom two panels of the garage panelled door on entering the loading dock. Building Management were onsite and captured the delivery driver's contacts details, CCTV footage and photos of the damage. An incident report was lodged. Due to this Building management have been working with StrataPlus and the insurers to claim back the expenses of \$10,714.00 for damages, including the replacement of the bottom two panels of the door. If successful, we should be able to claim back the full amount for damages.

Building Management are currently obtaining quotes to install speed bumps on the loading dock entrance driveway in order to slow down vehicles on entrance and help prevent future damages to the garage door.

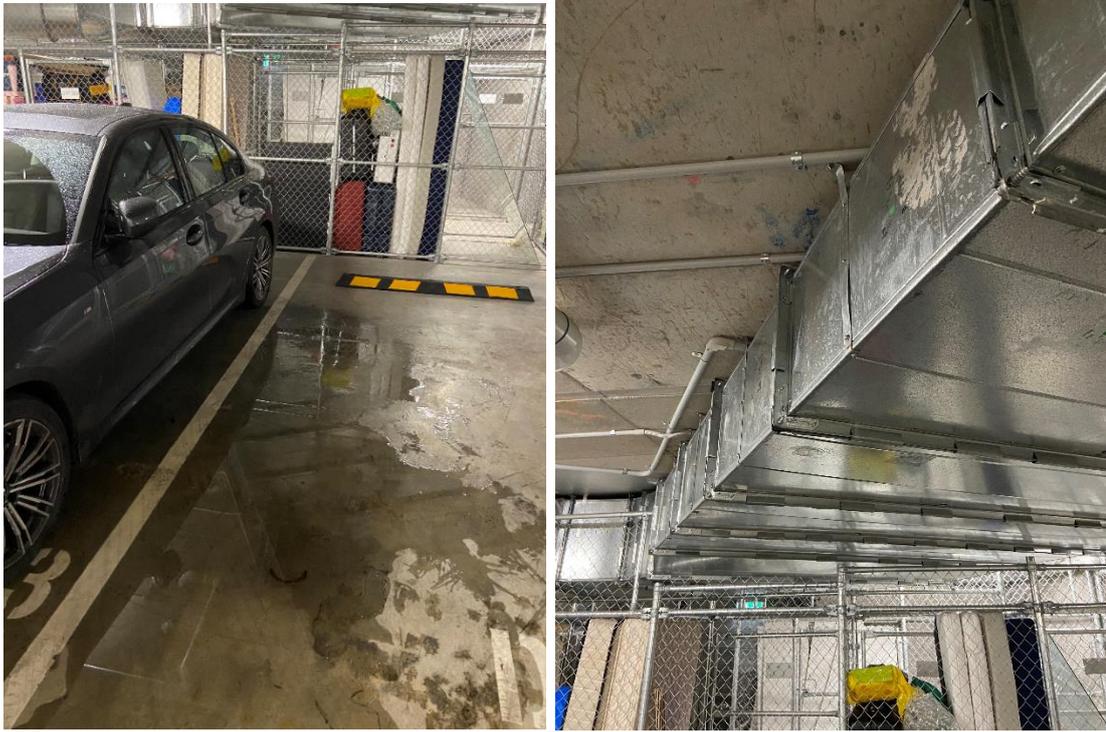
Building Management found a leak on a building walk with the recent heavy rainfall. This is an existing leak and has been reported to LendLease as a defect. Investigations are under way into where the leak is coming from.

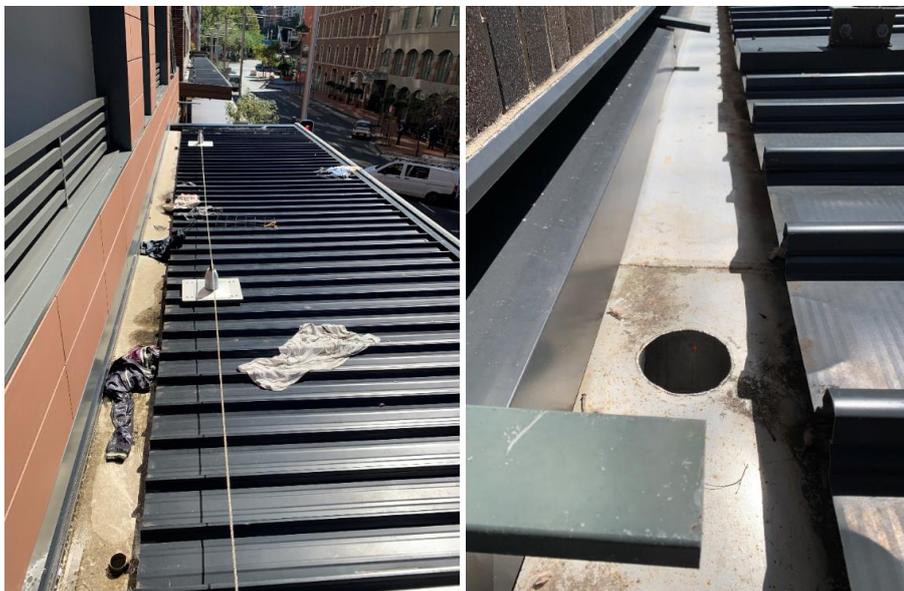
Building Management organized the clearing of the awning gutters on Harbour Street (situated over the loading). This is a preventive maintenance procedures to reduce the risk of blockages and overflow of rainwater onto the driveway and footpath of the carpark entrance.

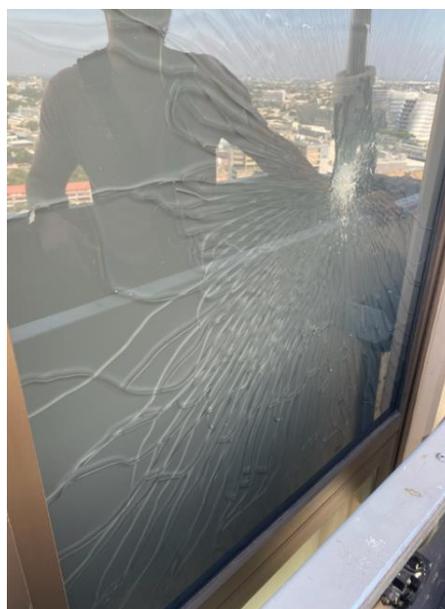
A broken spandrel panel was reported on the recent window clean on level 30 of the Façade. Spandrel Panels are the area of a curtain wall or screen located between vision areas of windows, which conceal structural columns, floor slabs and shear walls. It seems the window has been hit head on at high impact. Please refer to the photo below. A temporary, protective clear film has been placed on top of the broken panel to make safe until the panel is replaced.

Building Management have obtained two quotes, and are proceeding with the cheaper of the two quotes from Express Glass. A date is currently being organised between both parties to book the works in the works.
