BUILDING MANAGEMENT REPORT  
FOR

# DARLING SQUARE

**Premier FM Building Management**

**Monthly Report**

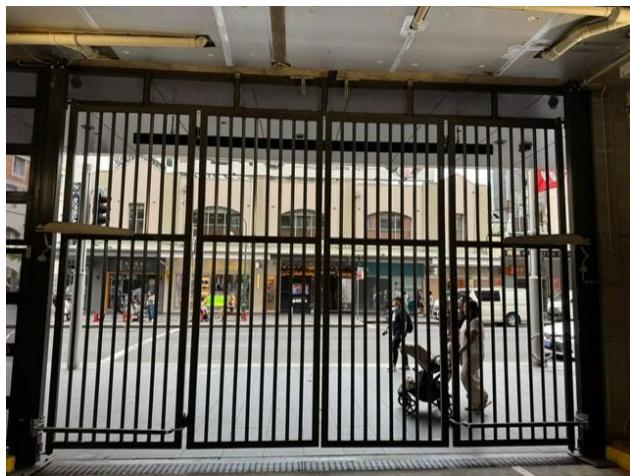
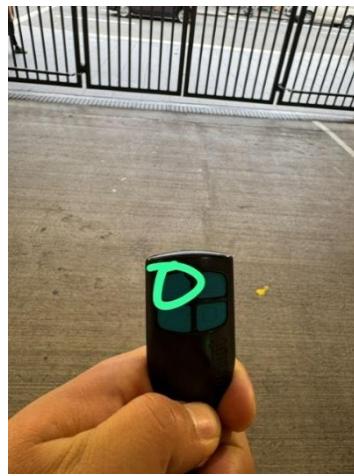
## 2.4 Access Control Outage – Garage Entry and Boom Gate (COMPLETED)

In the interim, the gate was left open manually to allow continued access, and an after-hours attendance by Allgate was scheduled to further investigate and resolve the matter. Upon arrival, Allgate confirmed that the issue was not mechanical in nature but was instead suspected to be an access control failure, specifically relating to the signal receiver.

A Supatech technician attended site Tuesday 16<sup>th</sup> December and was successful in resetting the garage entry receiver which has encountered an unknown fault. The device was tested ok after resetting with Building Management receiving training on how to complete this ourselves should a similar issue re-occur.

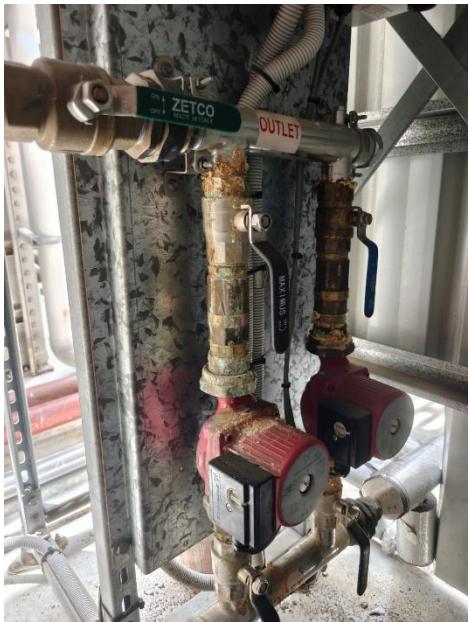
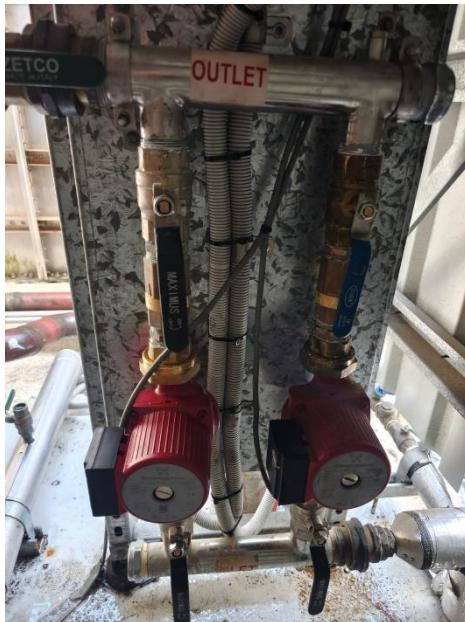
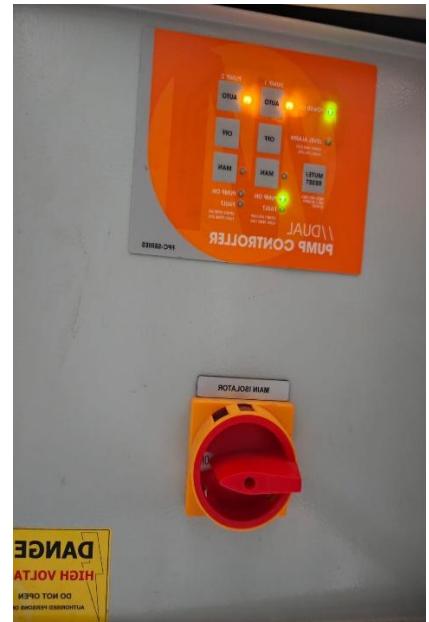
## Dual Hot Water Circulation Pump Replaced (COMPLETED)

During the quarterly hydraulics preventative maintenance inspection, it was discovered that one of the dual hot water circulation pumps located in the shared L30 plant area had seized. The pump was assessed as unrepairable and the recommendation was made to replace the asset.

Further inspection identified several localised leaks in unions and the manifold within the hot water system. These additional faults required attention as part of the repair works.

Given that the issue did not pose an immediate critical impact, Building Management sought a second quotation. Tradewise Group submitted a competitive quote of \$2,327.00 plus GST to carry out the required works. Building Management approved this quote, and Tradewise Group was engaged for the repairs.

All works have been successfully completed. The building's hot water utility was maintained throughout, with no interruption to service during the repair and replacement process.

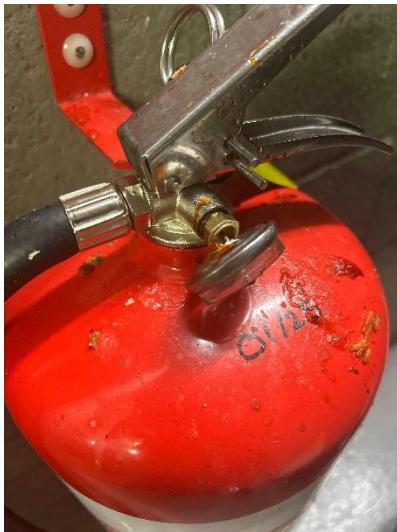
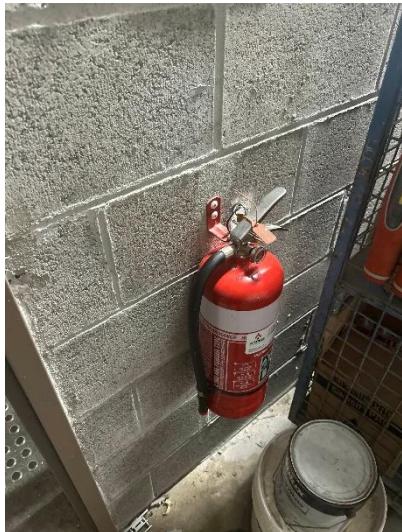
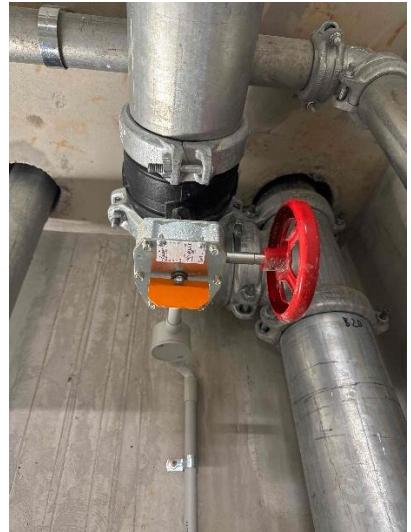
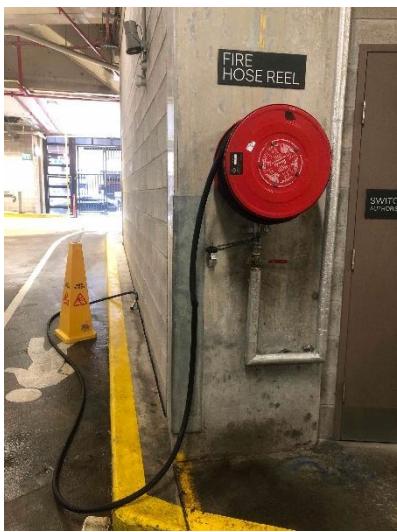
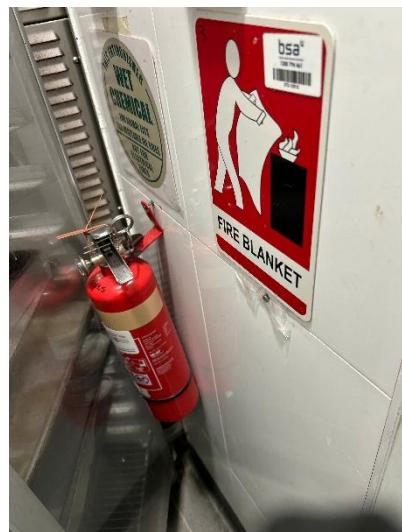
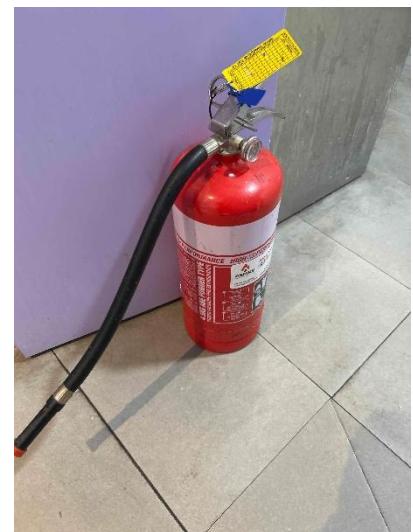
### Corrective Actions Portables & Signage (COMPLETED)

- Completed five-year pressure testing on three ABE extinguishers.
- Supplied and installed two 2L wet chemical extinguishers.
- Replaced two hose clamps.
- Installed 003 locks and chains on two landing valves.
- Put up two fire blankets.
- Posted signage: 'Fire Safety Door Do Not Obstruct' (one installed).
- Placed a 'Hose Reel Location Sign' (one installed).
- Added an 'ABE Extinguisher Location Sign.'

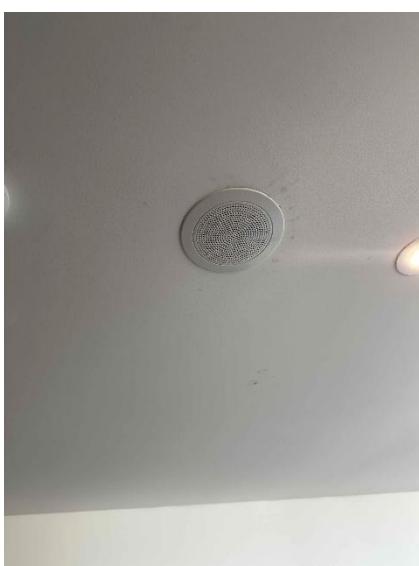
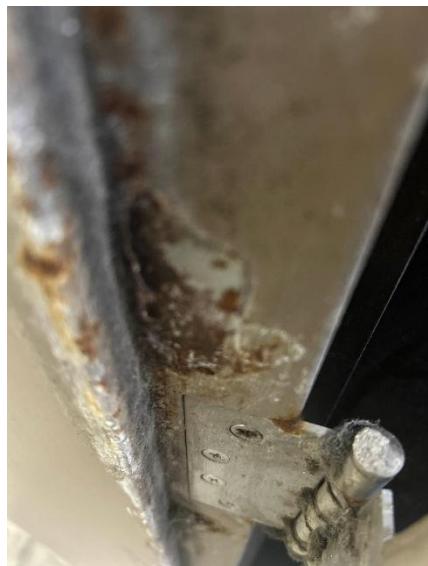
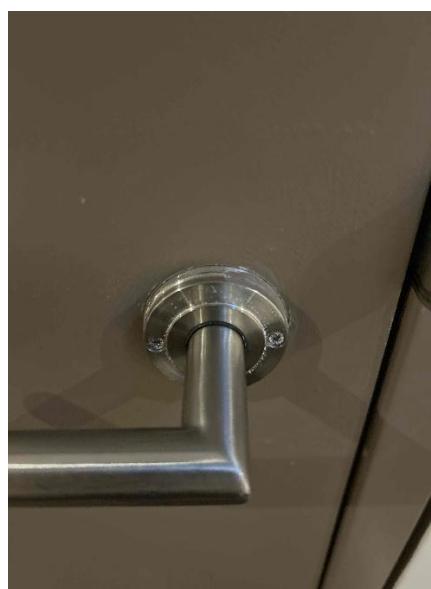
## Corrective Actions Passive Fire and Door sets (COMPLETED)

- Replace Escutcheon Plate x 1
- Minor Door Adjustments x 2
- Supply & Install Bat Wing Seal x1
- Supply and Install Intumescent Strip
- Replace 100mm Flush Mounted Speaker

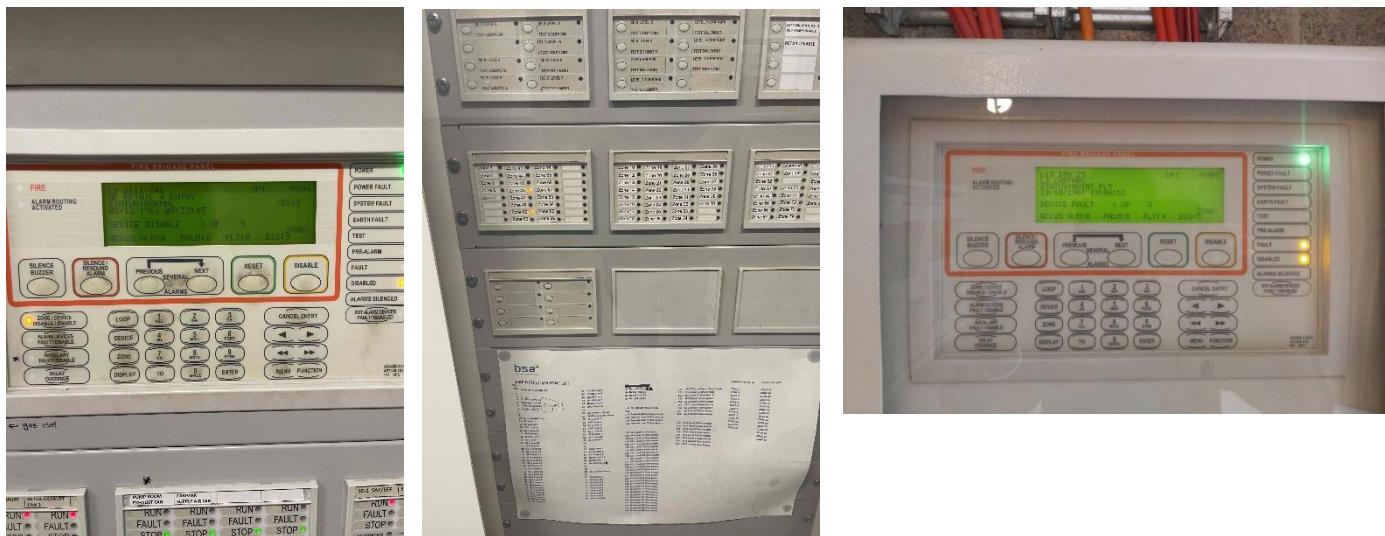
## Fire Indicator Panel Faults Cleared x 8 (COMPLETED)

Following identification of numerous faults apparent on the main FIP Aspire Fire were engaged to identify the underlying issues and resolve.

- SE3 L4 – Caused by loose cable to Fire Speakers; repaired.
- EWIS System x 2 – WIP dislodged from wall with cupboard, SE3 L4 & SE1 L5
- Detector Replaced L4 Car Park
- Replaced Input/Output Modules caused open circuit fault L13 Darling Rise
- Replace ‘Address Card’ Detectors D40 & D8
- Detector Fault L3 Car Park; replaced

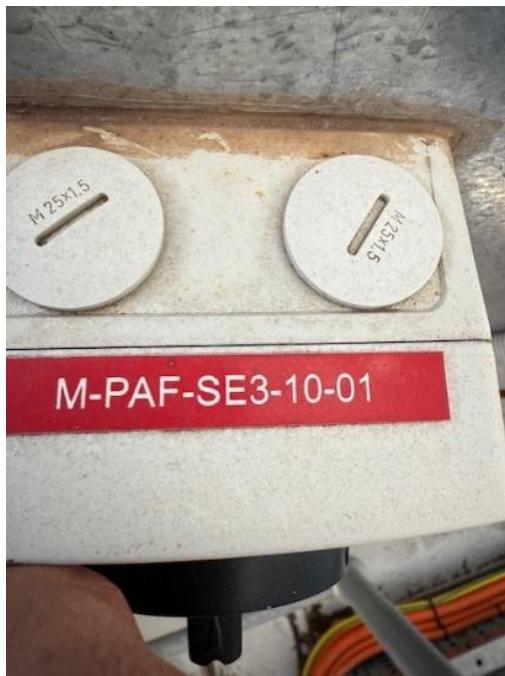
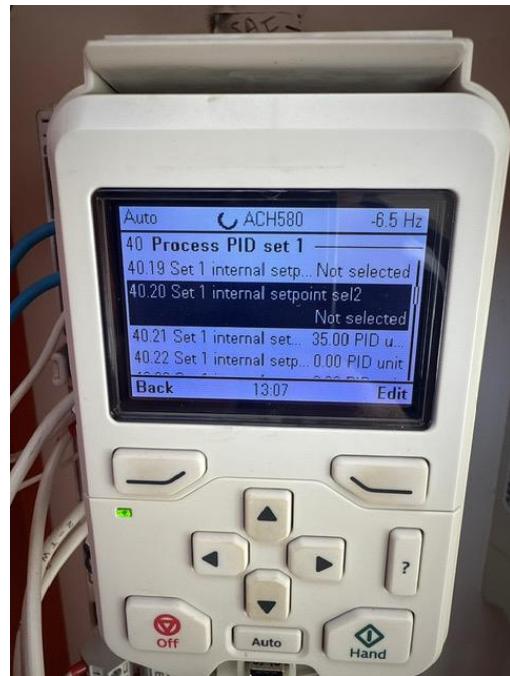
During the annual testing in the Arena building, it was observed that although the stair pressurisation fans activated and entered Fire Mode, the relief fan did not override as required by the system design.

To rectify this, all relevant VSD settings will be reinstated to their original design values.

Upon completion of the reprogramming, a comprehensive stair pressurisation test will be conducted to confirm correct operation and compliance with AS1668.

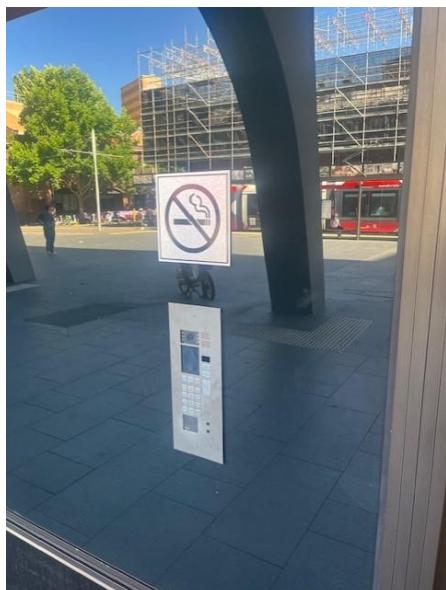
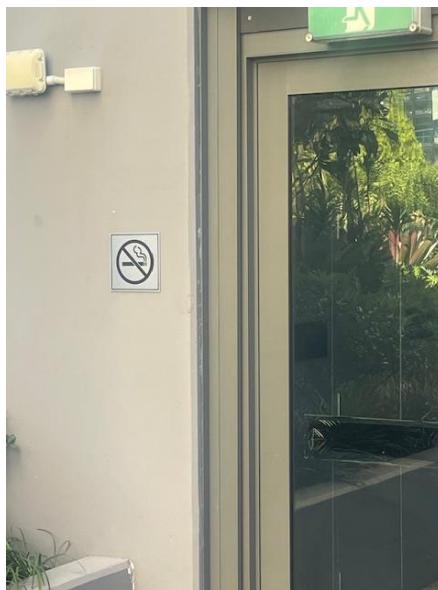
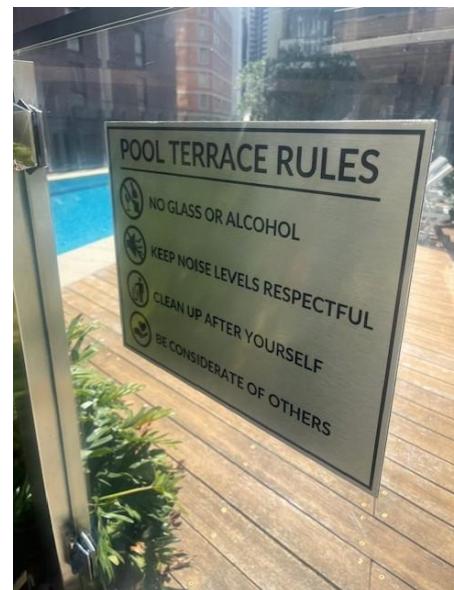
- Design, supply, and installation of two 'No Consumable' signs. The exact wording for these signs will be finalised during the design phase to ensure clarity and effectiveness.
- Provision and mounting of five 'No Smoking' signs, which will be strategically placed throughout Level 6 and at all foyer entry points to reinforce the building's smoke-free policy.

All signs have been manufactured to a high standard, suitable for external use, and have now been mounted at highly visible points at Pool Entry, surrounds and Building Entries (Both Ground Floor Foyer and L6 Doors).

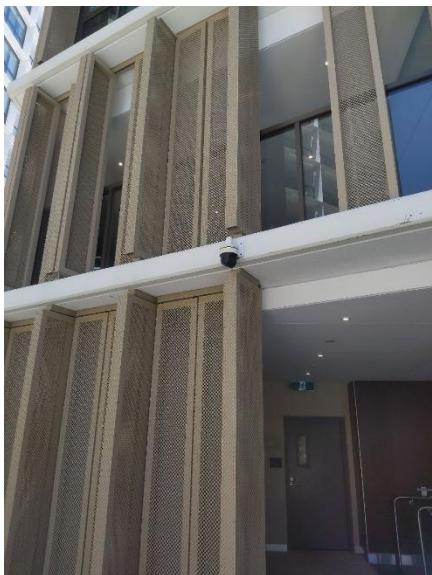
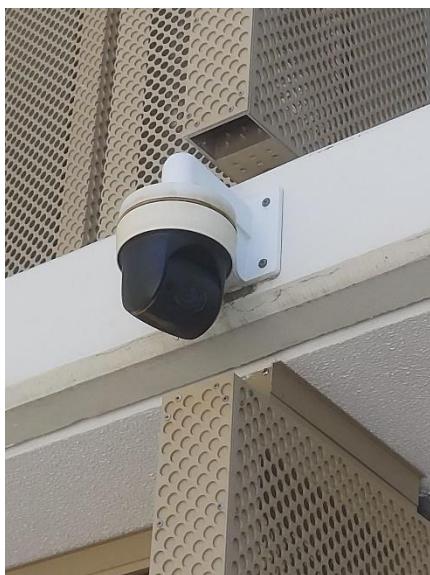
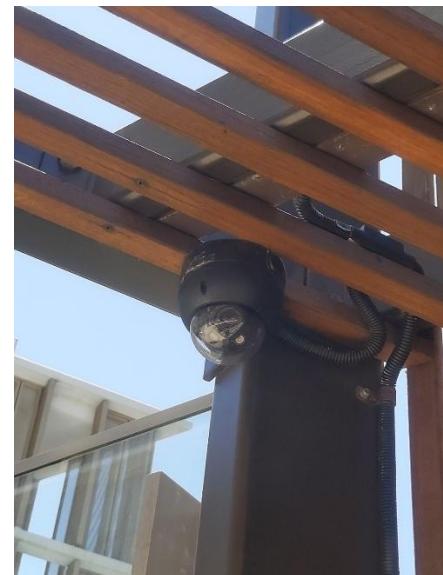
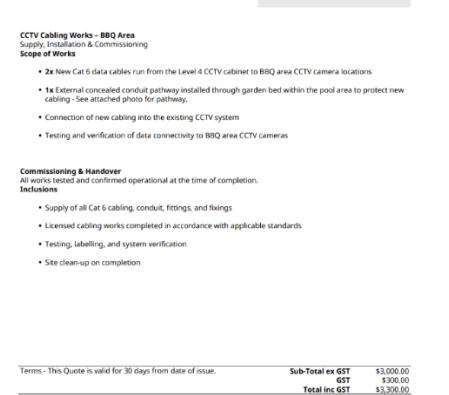
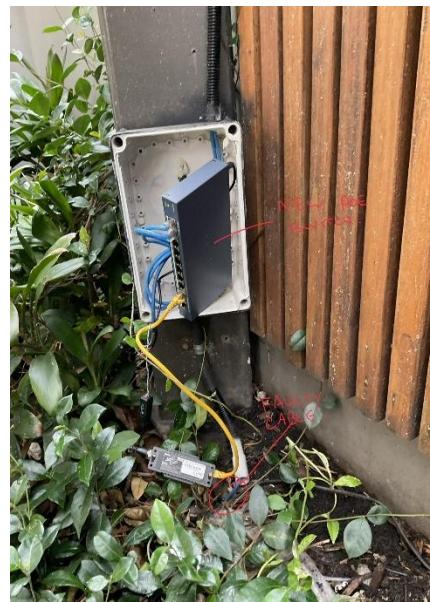
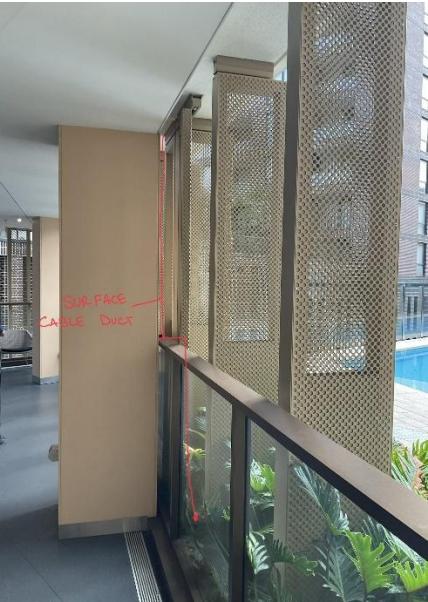
### CCTV Repairs L6 BBQ and Pool Areas (ONGOING)

It was noted that three cameras covering both the Pool and BBQ Area on L6 were unresponsive, supplying no signal to the NVR due to either camera malfunction or cabling failure.

All camera functionality was restored with the Pool Camera replaced however the fault with the BBQ pagoda cameras was traced to a fault in the cabling, which must be re-run to the appropriate junction on L4.

A quote has been supplied and approved for the completion of these works prior to the end of February.

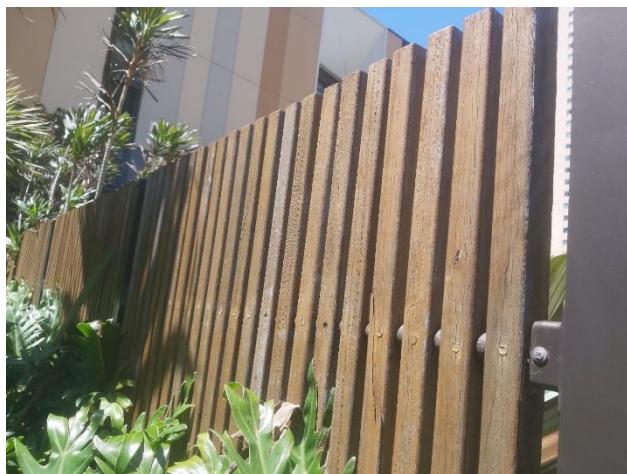
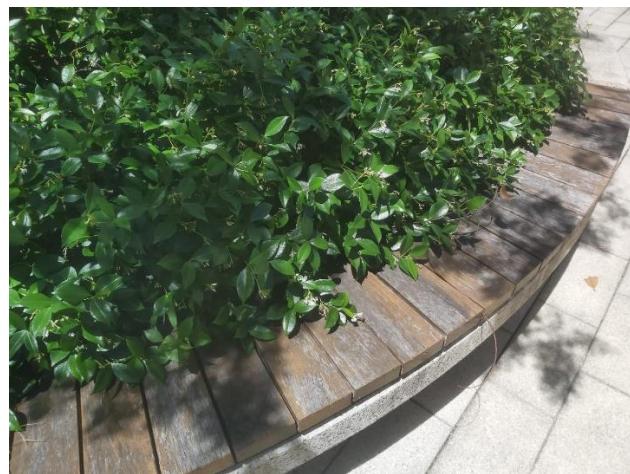
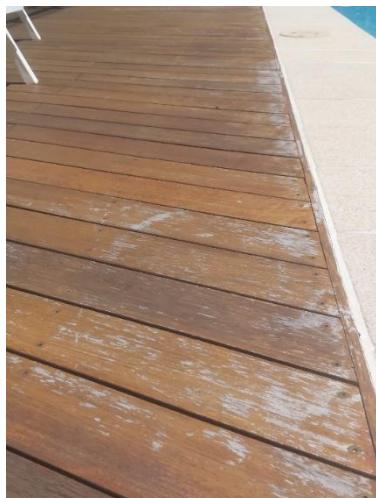
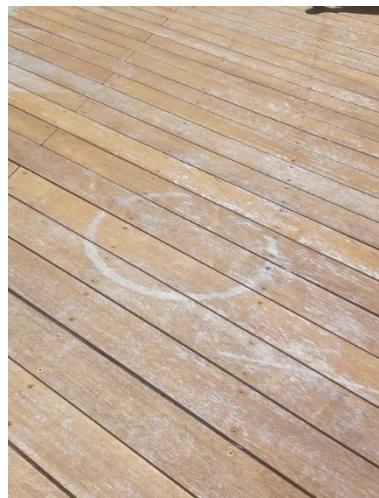
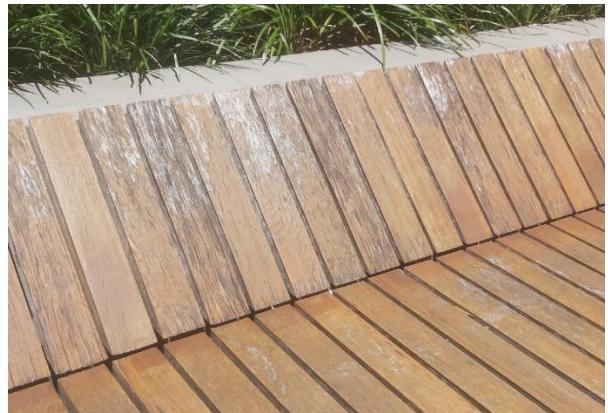
## L6 External Podium Timber Restoration (ONGOING)

A review of the timber elements throughout the L6 Podium Communal Area has identified moderate dilapidation. This deterioration is primarily due to prolonged weather exposure and an ongoing lack of preventative maintenance. Although most of the damage is largely aesthetic, it is important to address these issues to prevent further degradation of the timber and maintain the overall appearance and safety of the communal spaces.

- Sanding to remove old surface residues and rough textures from all timber elements
- Washing and cleaning all surfaces prior to the application of a water-based finish
- Applying a water-based finish to all treated surfaces to protect against future weathering
- General replacement of screws and fixings where necessary to securely refix timber elements to their frameworks

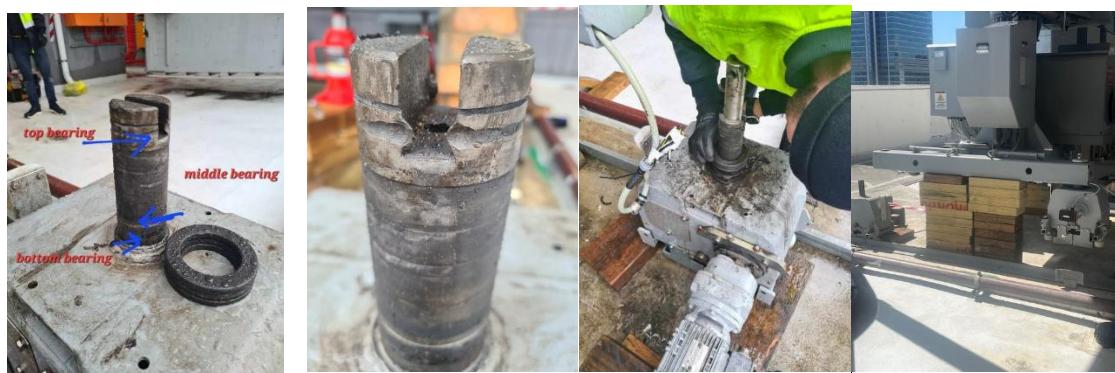
#### Building Maintenance Unit (BMU) Repairs – Shared Plant Level 30 (ONGOING)

The Building Maintenance Unit (BMU) located in the shared plant area on the Level 30 rooftop of Darling Rise had been out of operation since July 2025. This prolonged inactivity resulted in the delay of several critical maintenance, cleaning, and defect rectification tasks which remained on hold during this period.

Upon attending the site, PremierFM observed that the BMU was in a partially dismantled state and supported by blocks. There was a lack of detailed information in BuildingLink regarding the current status or any ongoing or completed works. Further investigation and direct communication with GDP revealed that works previously approved had commenced but were halted midway. The initial scope of work focused on the replacement of a faulty long travel drive bearing (Q-221580), which had been identified during a planned preventative maintenance inspection conducted on 13 May 2025.

The project was suspended after it became clear that additional bearings required replacement and that the necessary parts were not readily available. Complicating the repair, a locking collar (unthreaded) was discovered atop the travel drive shaft, inhibiting the removal of components. Additionally, damage to the drive shaft itself was noted.

Following investigation, the bearing shaft was successfully repaired by grinding and filing, removing the need for a new shaft. New thrust bearings were installed, and the electrical motor along with its associated components were reassembled and thoroughly tested. A successful full long-travel test was conducted to ensure operational reliability.

The final phase of the repairs involved conducting a comprehensive series of drop tests to ensure the Building Maintenance Unit's operational safety and reliability. During these tests, it was discovered that three lanyard interlocks were experiencing sensor failures. Despite an initial attempt to repair the affected sensors, the issue could not be resolved onsite. As a result, replacement sensors have been ordered directly from the manufacturer to address these failures. The system will undergo further programming and testing once the new components arrive, with the goal of restoring full functionality and compliance.

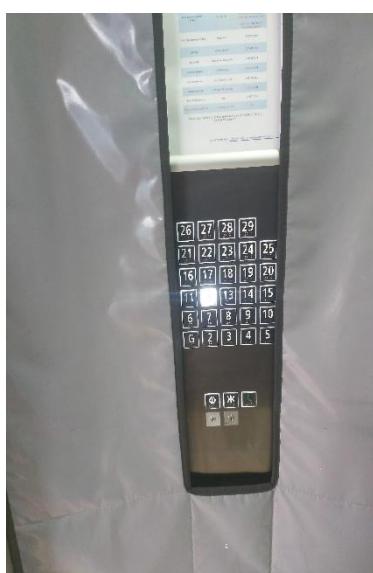
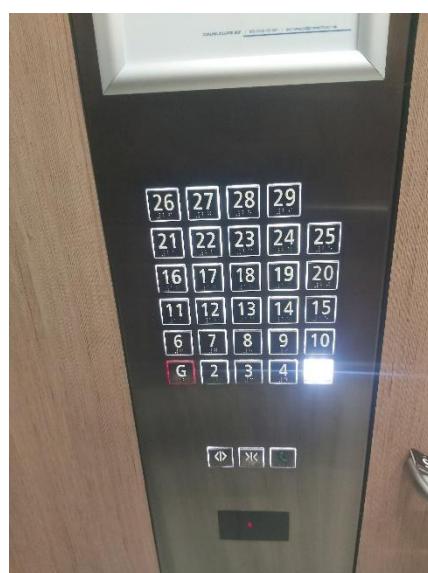
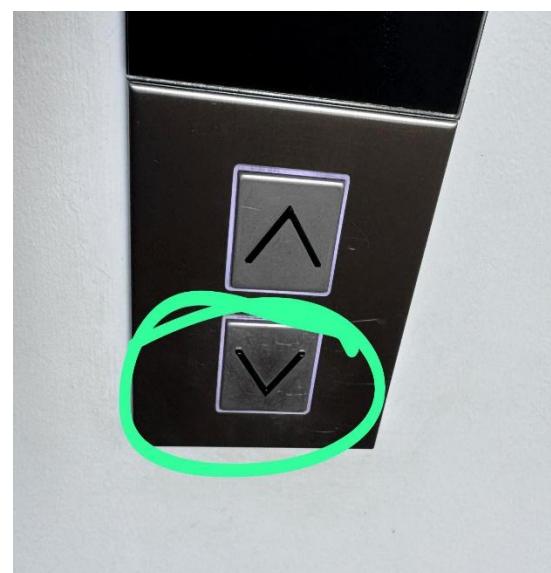
## Lift Repairs (COMPLETED)

Prior to PremierFM's arrival on site, a higher-than-average number of non-critical repairs had accumulated for the lift systems. These outstanding items were not immediately addressed, resulting in a backlog that required attention.

- Arena L5 Call Button Not Responding
- Darling Rise L15 Call Button Not Responding
- Lift 101 – Missing Buttons x 1, Loose buttons x 3
- Lift 102 – Missing Buttons x 1, Loose Buttons x 1
- Lift 103 – Missing Buttons x 2, loose Buttons x 2, Non-functioning Buttons x 2
- Lift 306 – Buttons Loose x 2
- Darling Rise Foyer Call Button #3 Not Responding

All known faults identified in the audit have now been repaired, with recent service issues receiving prompt attention. Schindler's responsiveness has notably improved in addressing service faults since the escalation and contract review process began.
