**DP1233930**

**Darling Square South East Plot  
Haymarket NSW 2000**

**February 2021**

**JLL Building Management  
Report**

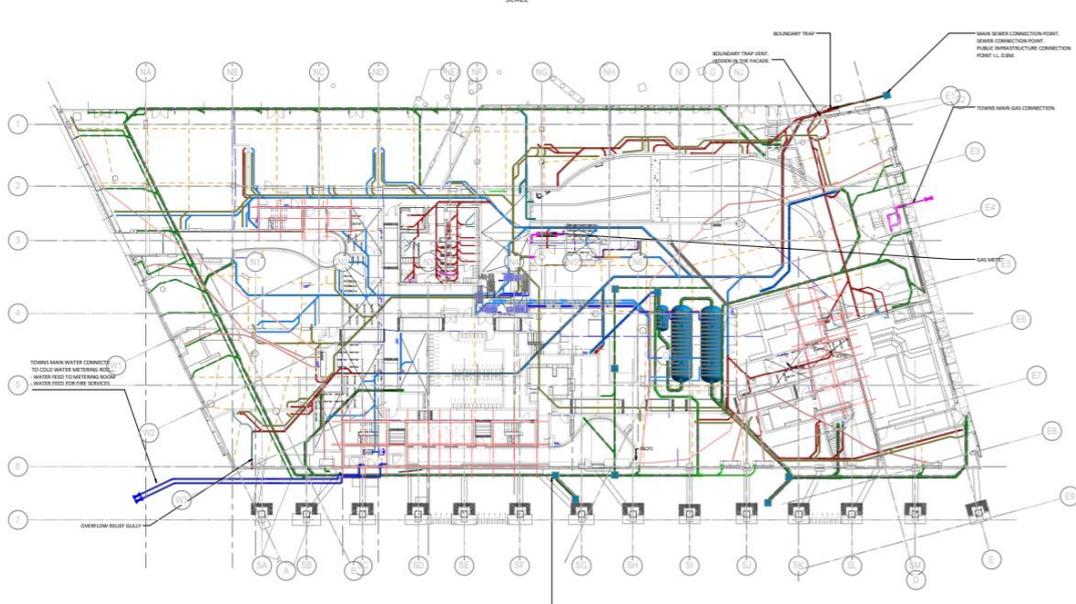
Ground floor – floor plan site layout showing the stormseptom system:

BM have been working on a service agreement for the stormseptom rain water tanks and filtration system. This system was installed as part of the Green Star Rating certification when Darling Square SEP was built. The two 40litre rain water tanks collect rain water which is then sent through a filtration system to the irrigation system and pumps water to the podium common area irrigation. This is designed to minimise our water usage and make the building more sustainable.

We have approached Spelstormwater, the manufacturers of the equipment for the service agreement. This will be a three year service agreement. The service agreement is for the following:

- Bi-annual inspections and maintenance
- Inspection and Maintenance: \$1,406.00 per annum
- Total Investment Value Per Annum: \$1,406.00 + GST

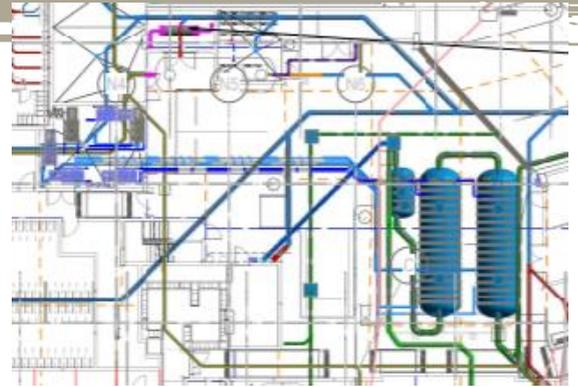
- Inspection of the coalescer chamber & unit (filter), and the alarm monitoring system (if applicable)
- If there is an oil/fuel build up (approx. 50mm) or after a spill, it will need to be vacuumed out. Costing to be confirmed at time of activity and will be additional cost to the standard contract value outlined below.

Spelstormwater have also advised we get a new coalesce (filter) at the following cost:

Supply and installation: 1x SPEL technician - \$607  
Coalescer unit: 1x - \$800  
Total cost: \$1,407 +GST
